ABSTRACT

This document describes the known exceptions to the functional specifications (advisories).

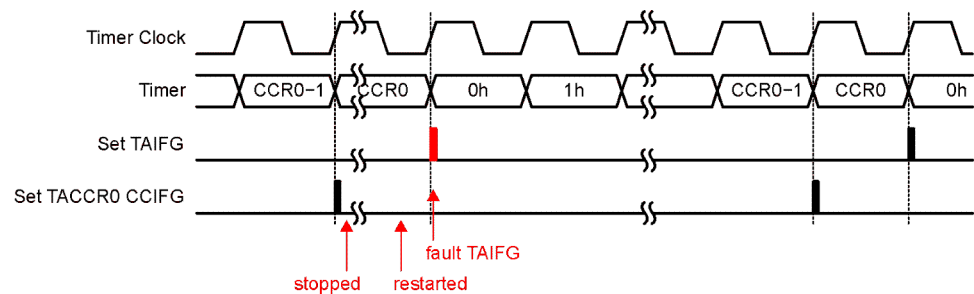
Function TAIFG Flag is erroneously set after Timer A restarts in Up Mode

Description In Up Mode, the TAIFG flag should only be set when the timer counts from TACCR0 to zero. However, if the Timer A is stopped at TAR = TACCR0, then cleared (TAR=0) by setting the TACLr bit, and finally restarted in Up Mode, the next rising edge of the TACLK will erroneously set the TAIFG flag.

Workaround None.
