MSP430F2234 Device Erratasheet

1 Functional Errata Revision History

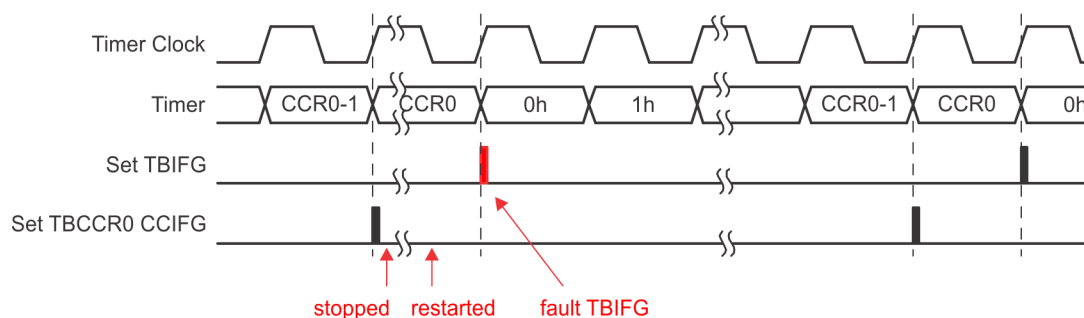
TB24 *TIMER_B Module*

Function TBIFG Flag is erroneously set after Timer B restarts in Up Mode

Description In Up Mode, the TBIFG flag should only be set when the timer resets from TBCCR0 to zero. However, if the Timer B is stopped at $TBR = TBCCR_0$, then cleared ($TBR=0$) by setting the TBCLR bit, and finally restarted in Up Mode, the next rising edge of the TBCLK will erroneously set the TBIFG flag.

Workaround None.
