ABSTRACT

This document describes the known exceptions to the functional specifications (advisories).

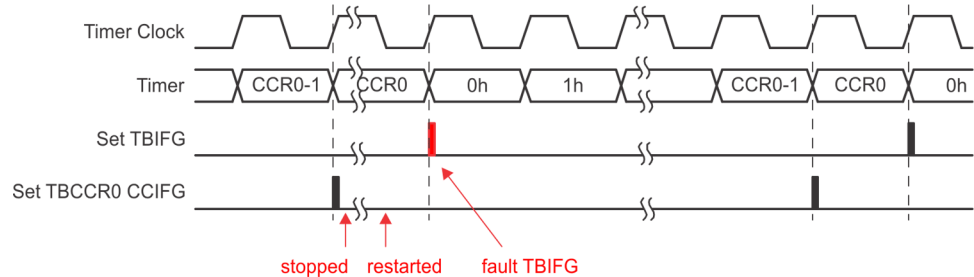
Description In Up Mode, the TBIFG flag should only be set when the timer resets from TBCCR0 to zero. However, if the Timer B is stopped at TBR = TBCCR0, then cleared (TBR=0) by setting the TBCLR bit, and finally restarted in Up Mode, the next rising edge of the TBCLK will erroneously set the TBIFG flag.

Workaround None.
