MSP430F2330 Device Erratasheet

1 Functional Errata Revision History

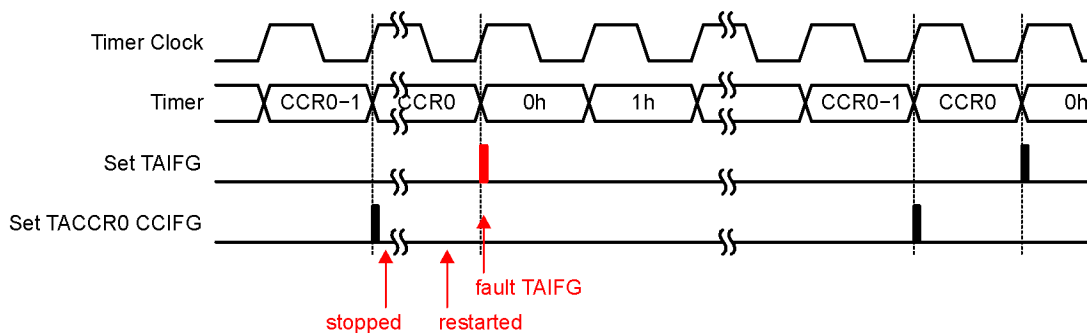
**TA21** *TIMER\_A Module*

| <b>Function</b> | TAIFG Flag is erroneously set after Timer A restarts in Up Mode |
| <b>Description</b> | In Up Mode, the TAIFG flag should only be set when the timer counts from TACCR0 to zero. However, if the Timer A is stopped at TAR = TACCR0, then cleared (TAR=0) by setting the TACLR bit, and finally restarted in Up Mode, the next rising edge of the TACLK will erroneously set the TAIFG flag. |

| <b>Workaround</b> | None. |

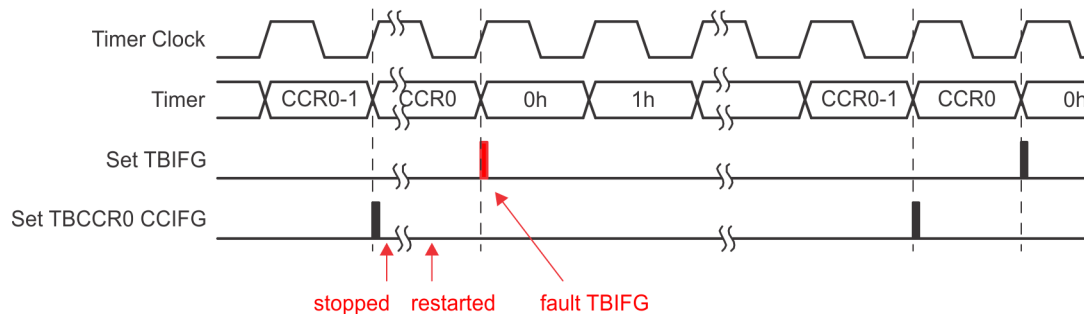
## **TB24** *TIMER\_B Module*

| <b>Function</b> | TBIFG Flag is erroneously set after Timer B restarts in Up Mode |

**Description** In Up Mode, the TBIFG flag should only be set when the timer resets from TBCCR0 to zero. However, if the Timer B is stopped at TBR = TBCCR0, then cleared (TBR=0) by setting the TBCLR bit, and finally restarted in Up Mode, the next rising edge of the TBCLK will erroneously set the TBIFG flag.

**Workaround** None.
