MSP430F2417 Device Erratasheet

1 Functional Errata Revision History

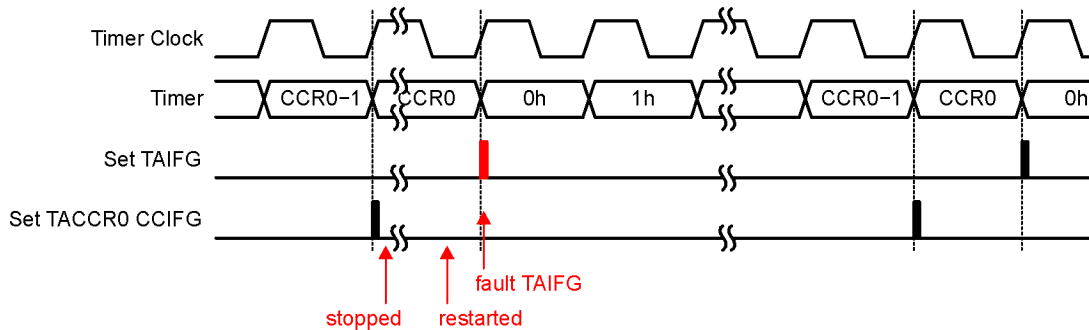
Function TAIFG Flag is erroneously set after Timer A restarts in Up Mode

Description In Up Mode, the TAIFG flag should only be set when the timer counts from TACCR0 to zero. However, if the Timer A is stopped at TAR = TACCR0, then cleared (TAR=0) by setting the TACLRL bit, and finally restarted in Up Mode, the next rising edge of the TACLK will erroneously set the TAIFG flag.

Workaround None.

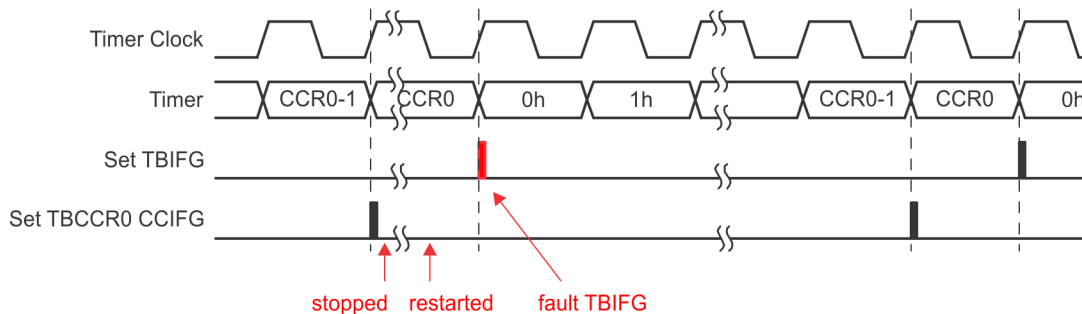
Function TBIFG Flag is erroneously set after Timer B restarts in Up Mode

Description In Up Mode, the TBIFG flag should only be set when the timer resets from TBCCR0 to zero. However, if the Timer B is stopped at $TBR = TBCCR0$, then cleared ($TBR=0$) by setting the TBCLR bit, and finally restarted in Up Mode, the next rising edge of the TBCLK will erroneously set the TBIFG flag.

Workaround None.
