MSP430F2417 Device Erratasheet

1 Functional Errata Revision History

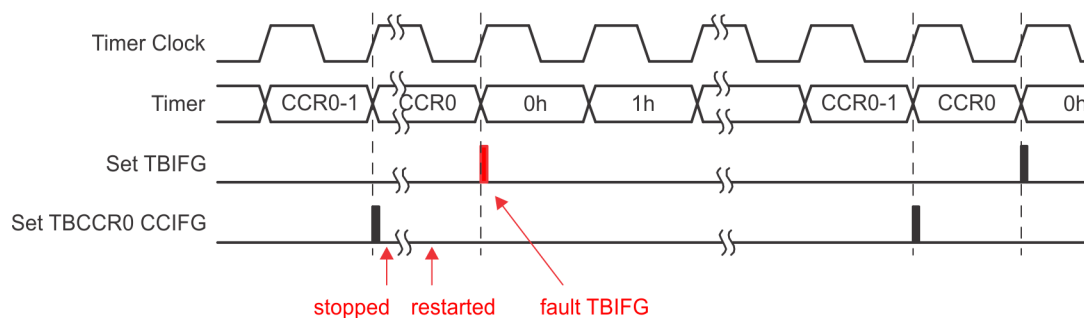
TB24	<i>TIMER_B Module</i>
Category	Functional
Function	TBIFG Flag is erroneously set after Timer B restarts in Up Mode
Description	In Up Mode, the TBIFG flag should only be set when the timer resets from TBCCR0 to zero. However, if the Timer B is stopped at TBR = TBCCR0, then cleared (TBR=0) by setting the TBCLR bit, and finally restarted in Up Mode, the next rising edge of the TBCLK will erroneously set the TBIFG flag.

Workaround	None.
-------------------	-------
