## MSP430F2418 Device Erratasheet

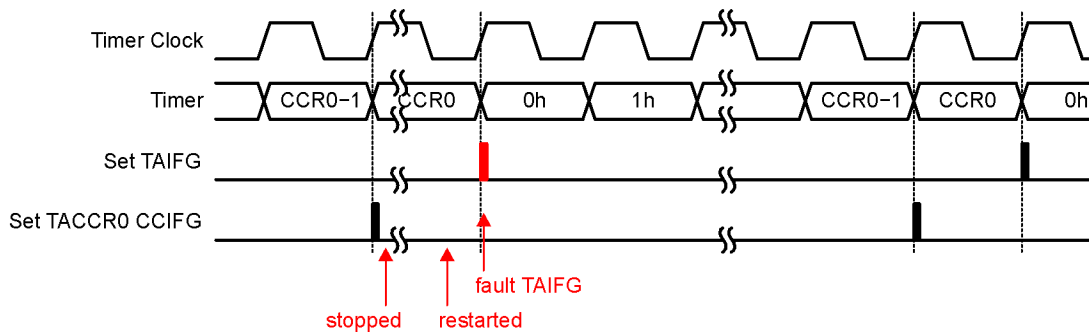
**Description** In Up Mode, the TAIFG flag should only be set when the timer counts from TACCR0 to zero. However, if the Timer A is stopped at TAR = TACCR0, then cleared (TAR=0) by setting the TACLRL bit, and finally restarted in Up Mode, the next rising edge of the TACLK will erroneously set the TAIFG flag.

**Workaround** None.
