ABSTRACT

This document describes the known exceptions to the functional specifications (advisories).

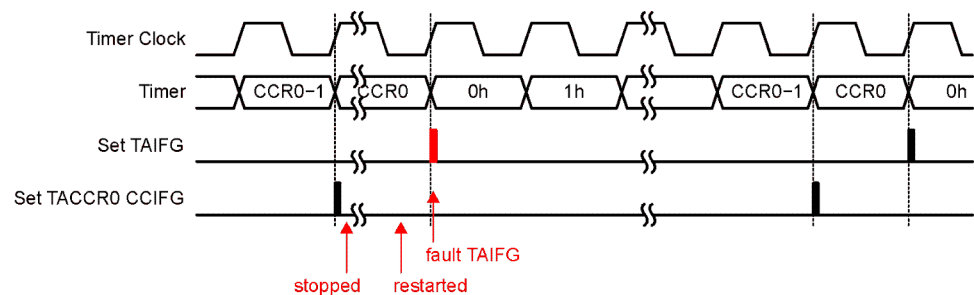
TA21

TAIFG Flag is erroneously set after Timer A restarts in Up Mode

In Up Mode, the TAIFG flag should only be set when the timer counts from TACCR0 to zero. However, if the Timer A is stopped at TAR = TACCR0, then cleared (TAR=0) by setting the TACLK bit, and finally restarted in Up Mode, the next rising edge of the TACLK will erroneously set the TAIFG flag.

None.

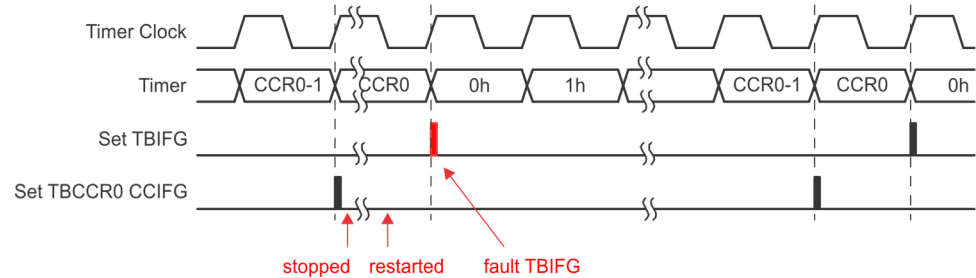
TB24 *TB Module*

Category	Functional
Function	TBIFG Flag is erroneously set after Timer B restarts in Up Mode

In Up Mode, the TBIFG flag should only be set when the timer resets from TBCCR0 to zero. However, if the Timer B is stopped at TBR = TBCCR0, then cleared (TBR=0) by setting the TBCLR bit, and finally restarted in Up Mode, the next rising edge of the TBCLK will erroneously set the TBIFG flag.

None.
