MSP430F249 Device Erratasheet

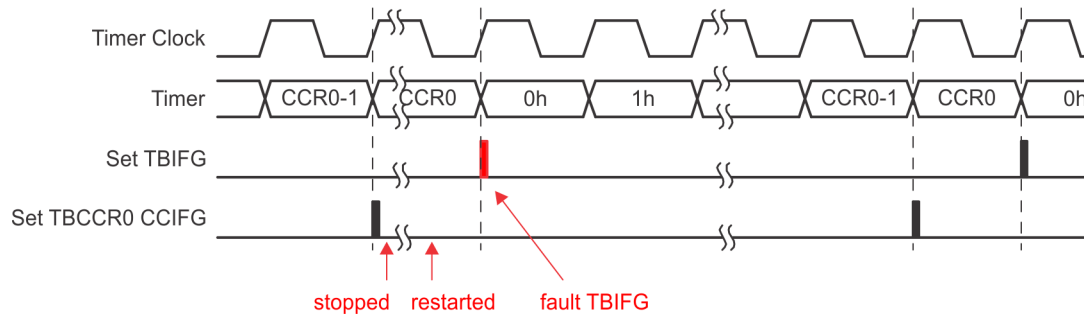
In Up Mode, the TBIFG flag should only be set when the timer resets from TBCCR0 to zero. However, if the Timer B is stopped at $TBR = TBCCR0$, then cleared ($TBR=0$) by setting the TBCLR bit, and finally restarted in Up Mode, the next rising edge of the TBCLK will erroneously set the TBIFG flag.

Workaround None.
