MSP430F2618 Device Erratasheet

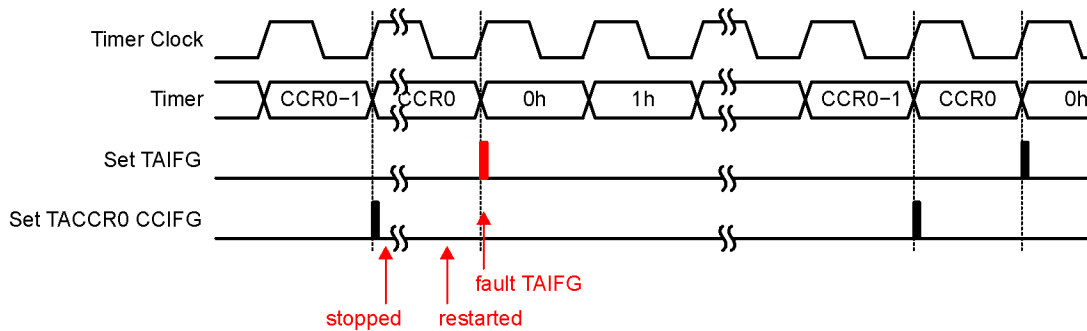
TA21 *TIMER_A Module*

Function TAIFG Flag is erroneously set after Timer A restarts in Up Mode

Description In Up Mode, the TAIFG flag should only be set when the timer counts from TACCR0 to zero. However, if the Timer A is stopped at TAR = TACCR0, then cleared (TAR=0) by setting the TACLRL bit, and finally restarted in Up Mode, the next rising edge of the TACLK will erroneously set the TAIFG flag.

Workaround None.
