MSP430F2619 Device Erratasheet

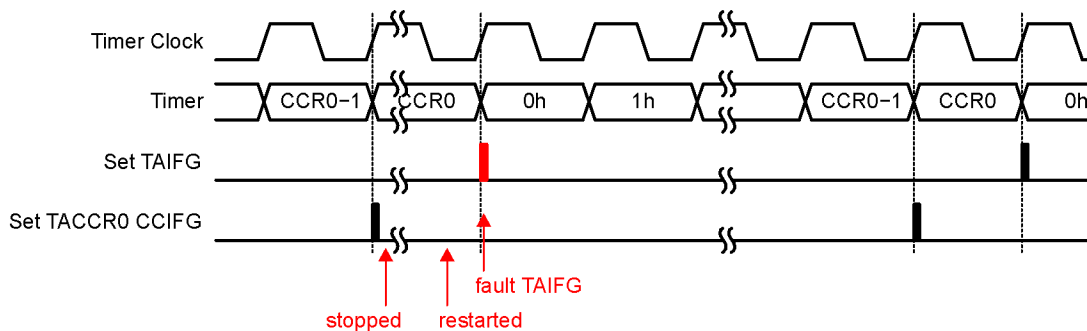
TA21 *TIMER_A Module*

Function TAIFG Flag is erroneously set after Timer A restarts in Up Mode

Description In Up Mode, the TAIFG flag should only be set when the timer counts from TACCR0 to zero. However, if the Timer A is stopped at TAR = TACCR0, then cleared (TAR=0) by setting the TACLRL bit, and finally restarted in Up Mode, the next rising edge of the TACLK will erroneously set the TAIFG flag.

Workaround None.

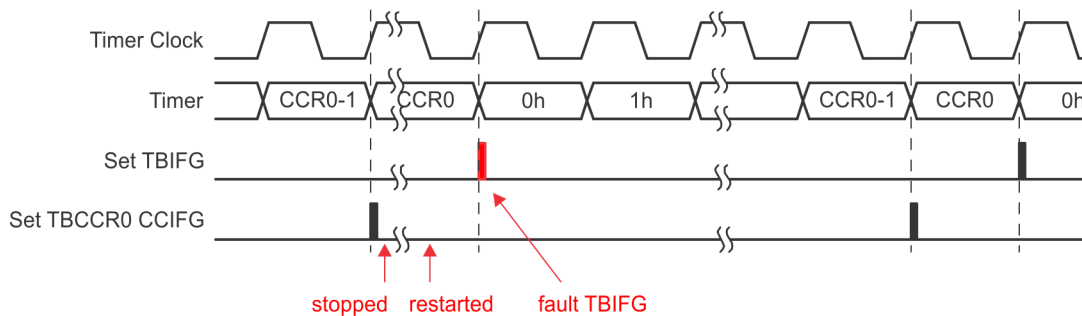
TB24 *TIMER_B Module*

Function TBIFG Flag is erroneously set after Timer B restarts in Up Mode

Description In Up Mode, the TBIFG flag should only be set when the timer resets from TBCCR0 to zero. However, if the Timer B is stopped at TBR = TBCCR0, then cleared (TBR=0) by setting the TBCLR bit, and finally restarted in Up Mode, the next rising edge of the TBCLK will erroneously set the TBIFG flag.

Workaround None.
