# MSP430F449 Device Erratasheet

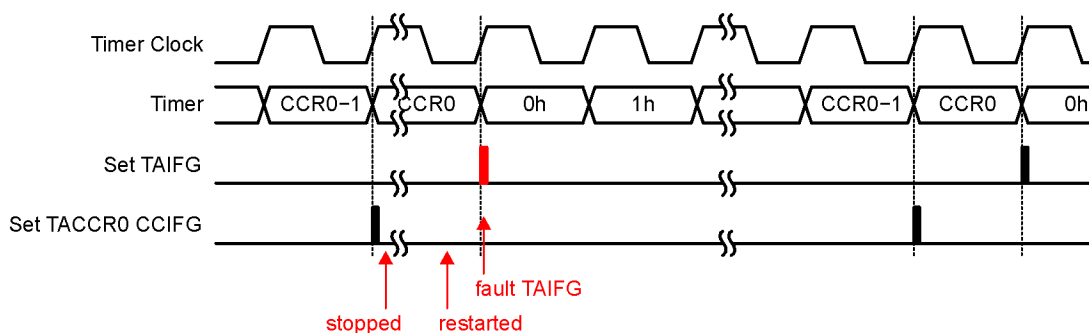
**TA21** *TIMER\_A Module*

**Function** TAIFG Flag is erroneously set after Timer A restarts in Up Mode

**Description** In Up Mode, the TAIFG flag should only be set when the timer counts from TACCR0 to zero. However, if the Timer A is stopped at TAR = TACCR0, then cleared (TAR=0) by setting the TACLr bit, and finally restarted in Up Mode, the next rising edge of the TACLK will erroneously set the TAIFG flag.

**Workaround** None.

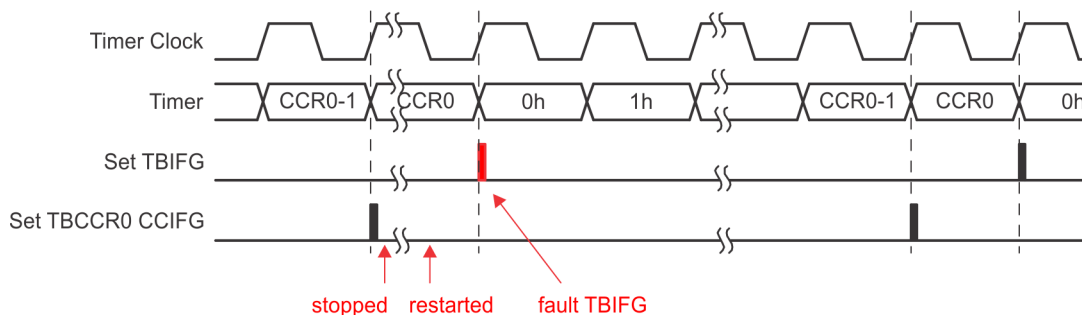
**TB24** *TIMER\_B Module*

**Function** TBIFG Flag is erroneously set after Timer B restarts in Up Mode

**Description** In Up Mode, the TBIFG flag should only be set when the timer resets from TBCCR0 to zero. However, if the Timer B is stopped at TBR = TBCCR0, then cleared (TBR=0) by setting the TBCLR bit, and finally restarted in Up Mode, the next rising edge of the TBCLK will erroneously set the TBIFG flag.

**Workaround** None.
