ABSTRACT

This document describes the known exceptions to the functional specifications (advisories).

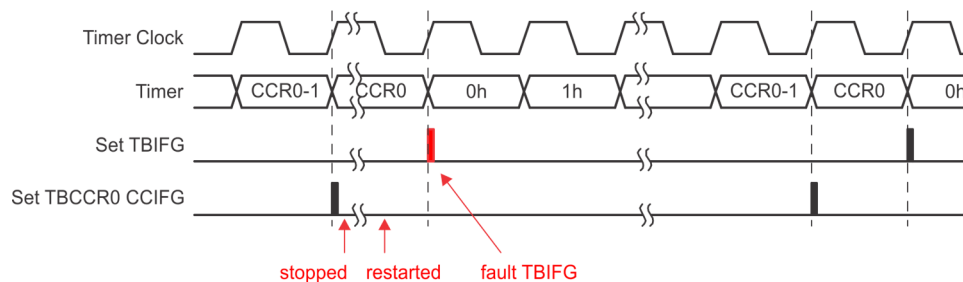
TB24 *TB Module*

Category	Functional
Function	TBIFG Flag is erroneously set after Timer B restarts in Up Mode
Description	<p>In Up Mode, the TBIFG flag should only be set when the timer resets from TBCCR0 to zero. However, if the Timer B is stopped at TBR = TBCCR0, then cleared (TBR=0) by setting the TBCLR bit, and finally restarted in Up Mode, the next rising edge of the TBCLK will erroneously set the TBIFG flag.</p>

Workaround	None.
-------------------	-------
