Errata
MSP430F4616 Microcontroller

This document describes the known exceptions to the functional specifications (advisories).

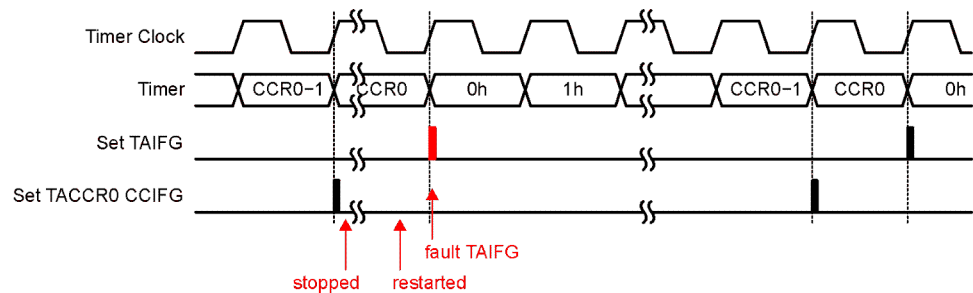
TA21 *TA Module*

Function TAIFG Flag is erroneously set after Timer A restarts in Up Mode

Description In Up Mode, the TAIFG flag should only be set when the timer counts from TACCR0 to zero. However, if the Timer A is stopped at TAR = TACCR0, then cleared (TAR=0) by setting the TACLK bit, and finally restarted in Up Mode, the next rising edge of the TACLK will erroneously set the TAIFG flag.

Workaround None.

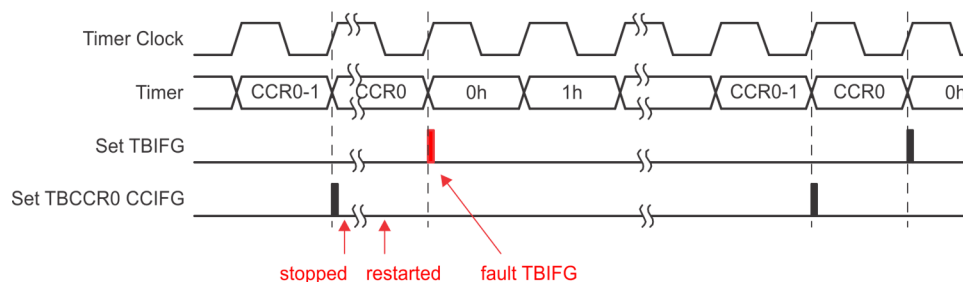
TB24

TBIFG Flag is erroneously set after Timer B restarts in Up Mode

In Up Mode, the TBIFG flag should only be set when the timer resets from TBCCR0 to zero. However, if the Timer B is stopped at TBR = TBCCR0, then cleared (TBR=0) by setting the TBCLR bit, and finally restarted in Up Mode, the next rising edge of the TBCLK will erroneously set the TBIFG flag.

None.
