MSP430F46171 Device Erratasheet

1 Functional Errata Revision History

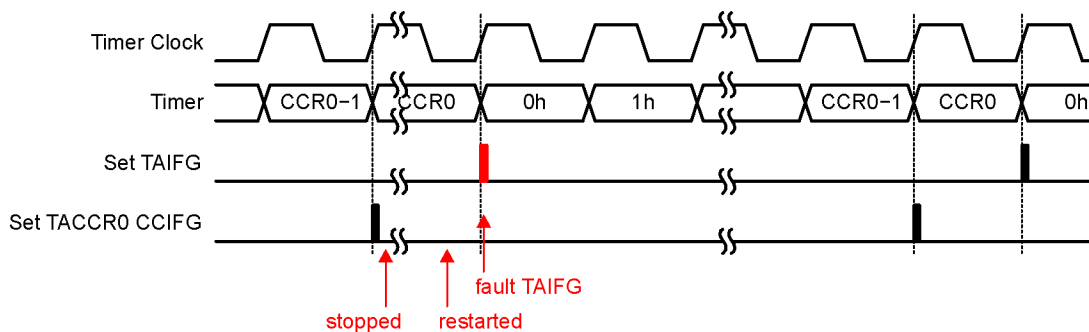
TA21 *TIMER_A Module*

Function TAIFG Flag is erroneously set after Timer A restarts in Up Mode

Description In Up Mode, the TAIFG flag should only be set when the timer counts from TACCR0 to zero. However, if the Timer A is stopped at TAR = TACCR0, then cleared (TAR=0) by setting the TACL R bit, and finally restarted in Up Mode, the next rising edge of the TACL K will erroneously set the TAIFG flag.

Workaround None.

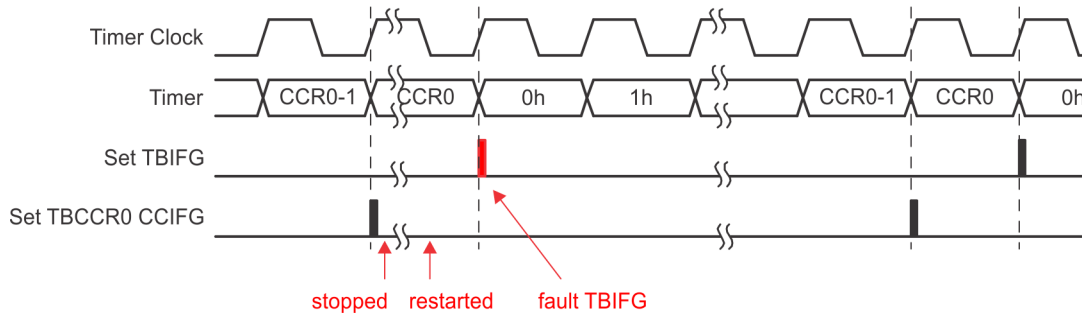
TB24 *TIMER_B Module*

Function TBIFG Flag is erroneously set after Timer B restarts in Up Mode

Description In Up Mode, the TBIFG flag should only be set when the timer resets from TBCCR0 to zero. However, if the Timer B is stopped at TBR = TBCCR0, then cleared (TBR=0) by setting the TBCLR bit, and finally restarted in Up Mode, the next rising edge of the TBCLK will erroneously set the TBIFG flag.

Workaround None.
