Errata  
**MSP430F47167 Microcontroller**

**ABSTRACT**

This document describes the known exceptions to the functional specifications (advisories).

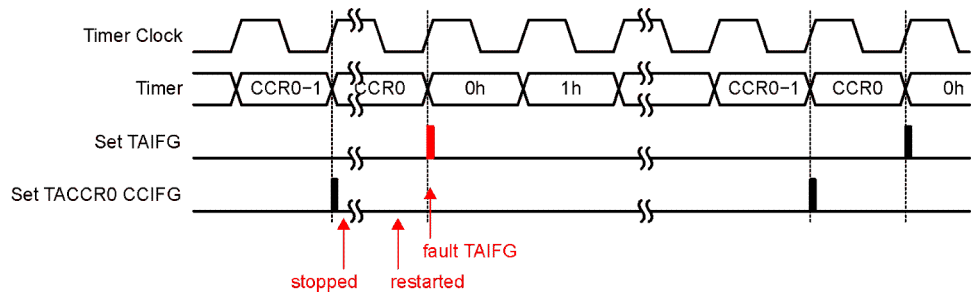
**TA21** *TA Module*

**Function** TAIFG Flag is erroneously set after Timer A restarts in Up Mode

**Description** In Up Mode, the TAIFG flag should only be set when the timer counts from TACCR0 to zero. However, if the Timer A is stopped at TAR = TACCR0, then cleared (TAR=0) by setting the TACLr bit, and finally restarted in Up Mode, the next rising edge of the TACLK will erroneously set the TAIFG flag.

**Workaround** None.
