MSP430F47176 Device Erratasheet

1 Functional Errata Revision History

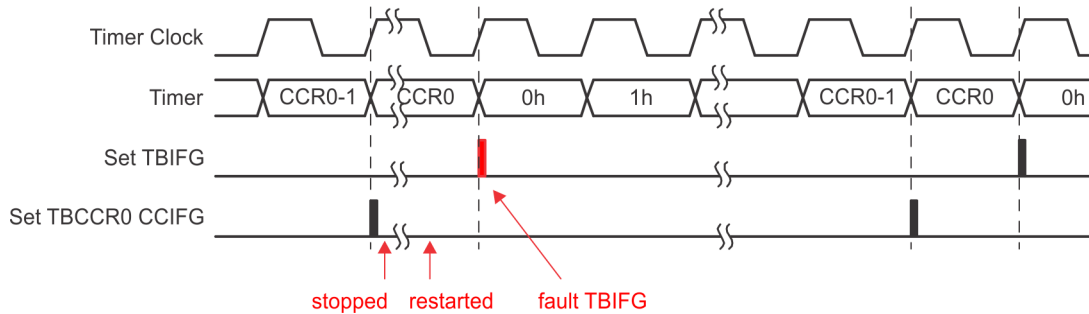
TB24
TIMER_B Module

TBIFG Flag is erroneously set after Timer B restarts in Up Mode

In Up Mode, the TBIFG flag should only be set when the timer resets from TBCCR0 to zero. However, if the Timer B is stopped at TBR = TBCCR0, then cleared (TBR=0) by setting the TBCLR bit, and finally restarted in Up Mode, the next rising edge of the

TBCLK will erroneously set the TBIFG flag.

Workaround None.
