MSP430F47193 Device Erratasheet

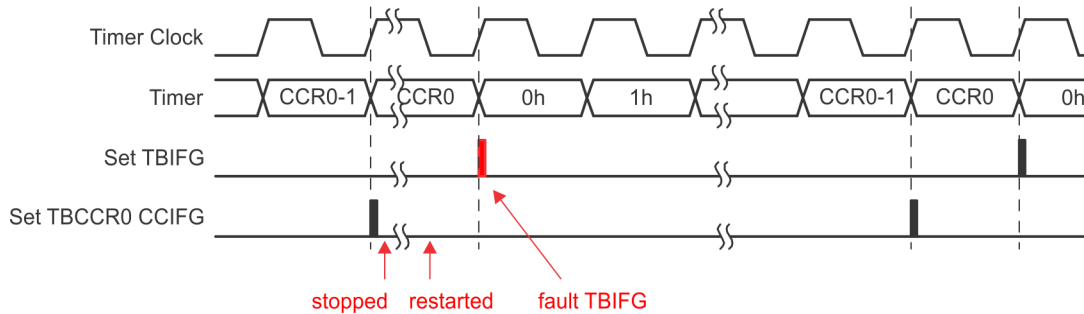
TB24
TIMER_B Module

TBIFG Flag is erroneously set after Timer B restarts in Up Mode

In Up Mode, the TBIFG flag should only be set when the timer resets from TBCCR0 to zero. However, if the Timer B is stopped at TBR = TBCCR0, then cleared (TBR=0) by setting the TBCLR bit, and finally restarted in Up Mode, the next rising edge of the

TBCLK will erroneously set the TBIFG flag.

Workaround None.
