MSP430F479 Device Erratasheet

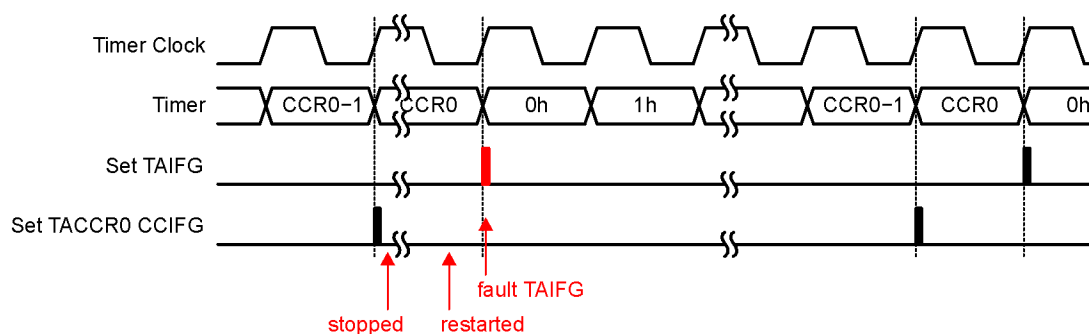
Function TAIFG Flag is erroneously set after Timer A restarts in Up Mode

Description In Up Mode, the TAIFG flag should only be set when the timer counts from TACCR0 to zero. However, if the Timer A is stopped at TAR = TACCR0, then cleared (TAR=0) by setting the TACLR bit, and finally restarted in Up Mode, the next rising edge of the TACLK will erroneously set the TAIFG flag.

Workaround None.
