MSP430F4794 Device Erratasheet

1 Functional Errata Revision History

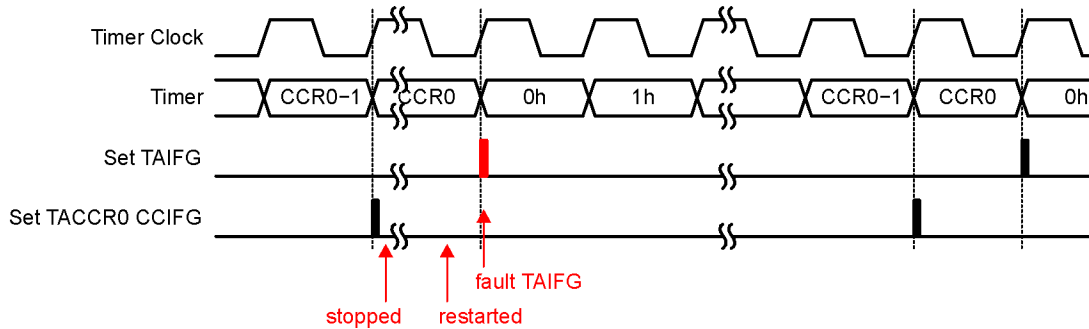
TA21

TAIFG Flag is erroneously set after Timer A restarts in Up Mode

In Up Mode, the TAIFG flag should only be set when the timer counts from TACCR0 to zero. However, if the Timer A is stopped at TAR = TACCR0, then cleared (TAR=0) by setting the TACLK bit, and finally restarted in Up Mode, the next rising edge of the

TACLK will erroneously set the TAIFG flag.

Workaround None.

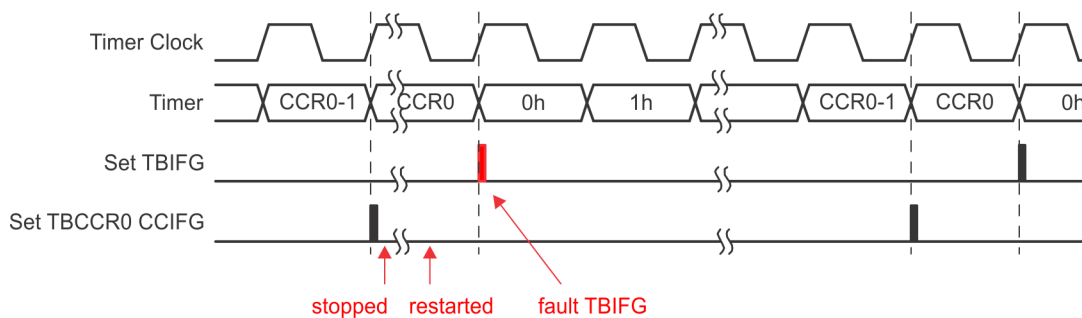
TB24 *TIMER_B Module*

Function TBIFG Flag is erroneously set after Timer B restarts in Up Mode

Description In Up Mode, the TBIFG flag should only be set when the timer resets from TBCCR0 to zero. However, if the Timer B is stopped at TBR = TBCCR0, then cleared (TBR=0) by setting the TBCLR bit, and finally restarted in Up Mode, the next rising edge of the TBCLK will erroneously set the TBIFG flag.

Workaround None.
