## ABSTRACT

This document describes the known exceptions to the functional specifications (advisories).

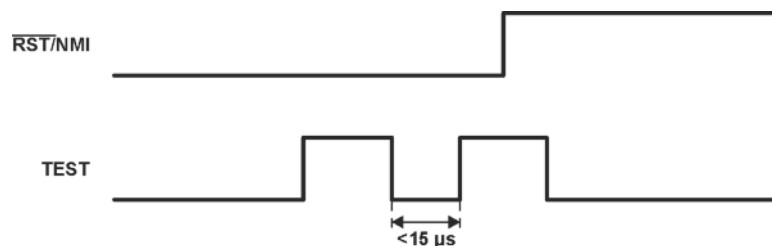
The BSL entry sequence requires that the low phase of the TEST/SBWTCCK pin does not exceed 15us. This timing requirement is faster than most PC serial ports can provide, as shown in the following picture. If this requirement is not met, the entry sequence fails and the SYSBSLIND is not set.

**Workaround** An external hardware solution is recommended to provide the appropriate BSL entry sequence. See [http://processors.wiki.ti.com/index.php/BSL\\_\(MSP430\)](http://processors.wiki.ti.com/index.php/BSL_(MSP430)) for recommendations on available BSL hardware.
