## ABSTRACT

This document describes the known exceptions to the functional specifications (advisories).

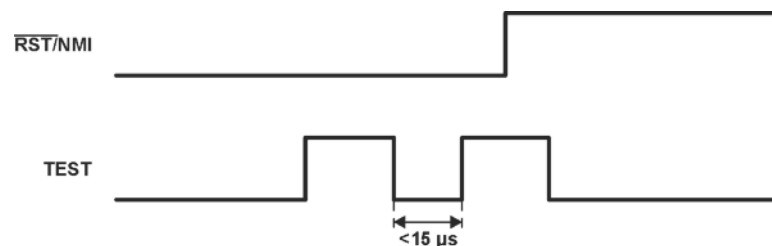
The BSL entry sequence requires that the low phase of the TEST/SBWTCK pin does not exceed 15us. This timing requirement is faster than most PC serial ports can provide, as shown in the following picture. If this requirement is not met, the entry sequence fails and the SYSBSLIND is not set.

**Workaround** An external hardware solution is recommended to provide the appropriate BSL entry sequence. See [http://processors.wiki.ti.com/index.php/BSL\\_\(MSP430\)](http://processors.wiki.ti.com/index.php/BSL_(MSP430)) for recommendations on available BSL hardware.
