## ABSTRACT

This document describes the known exceptions to the functional specifications (advisories).

## 1 Functional Advisories

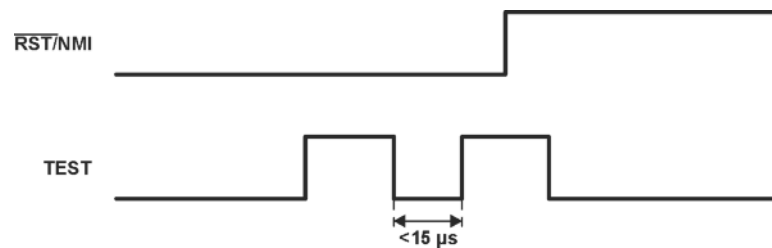
The BSL entry sequence requires that the low phase of the TEST/SBWTCK pin does not exceed 15 $\mu$ s. This timing requirement is faster than most PC serial ports can provide, as shown in the following picture. If this requirement is not met, the entry sequence fails and the SYSBSLIND is not set.

**Workaround** An external hardware solution is recommended to provide the appropriate BSL entry sequence. See [http://processors.wiki.ti.com/index.php/BSL\\_\(MSP430\)](http://processors.wiki.ti.com/index.php/BSL_(MSP430)) for recommendations on available BSL hardware.
