ABSTRACT

This document describes the known exceptions to the functional specifications (advisories).

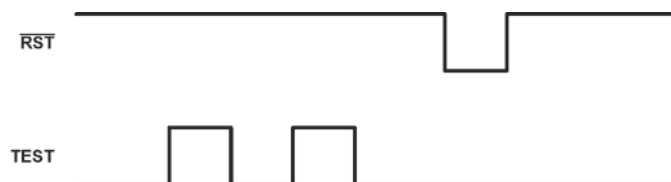
Note: This toggling of TEST pins is not subject to timing constraints. The appropriate level transitions on TEST pin, followed by a RST pulse after 50us, are sufficient to trigger an exit from BSL mode.

- Toggle the TEST pin twice when nRST is high and after 50us pull nRST low.

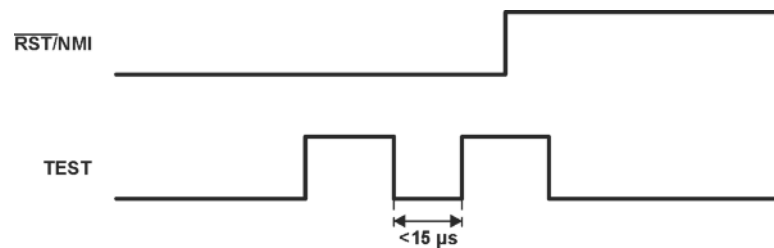
The BSL entry sequence requires that the low phase of the TEST/SBWTCK pin does not exceed 15 μ s. This timing requirement is faster than most PC serial ports can provide, as shown in the following picture. If this requirement is not met, the entry sequence fails and the SYSBSLIND is not set.

Workaround An external hardware solution is recommended to provide the appropriate BSL entry sequence. See [http://processors.wiki.ti.com/index.php/BSL_\(MSP430\)](http://processors.wiki.ti.com/index.php/BSL_(MSP430)) for recommendations on available BSL hardware.
