# MSP430F5437A Device Erratasheet

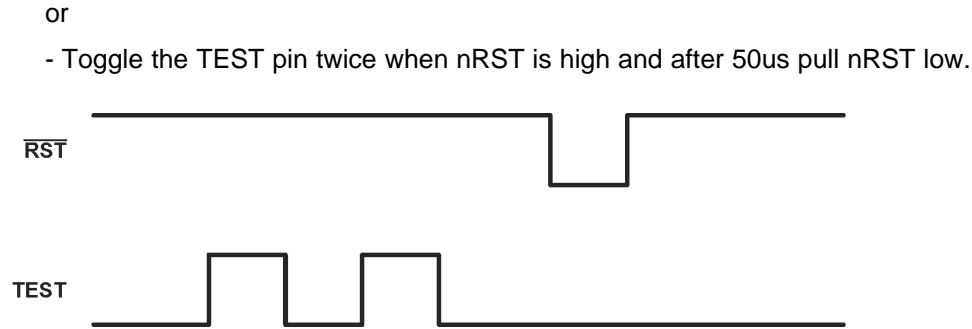
Note: This toggling of TEST pins is not subject to timing constraints. The appropriate level transitions on TEST pin, followed by a RST pulse after 50us, are sufficient to trigger an exit from BSL mode.
