MSP430F5501 Device Erratasheet

1 Functional Errata Revision History

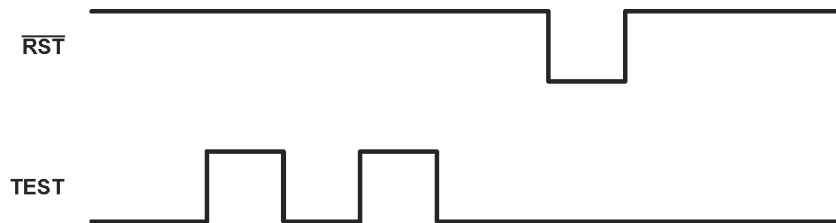
To exit the BSL one of the following methods must be used.

Note: This toggling of TEST pins is not subject to timing constraints. The appropriate level transitions on TEST pin, followed by a RST pulse after 50us, are sufficient to trigger an exit from BSL mode.

- A Power cycle
- or
- Toggle the TEST pin twice when nRST is high and after 50us pull nRST low.
