# MSP430F5506 Device Erratasheet

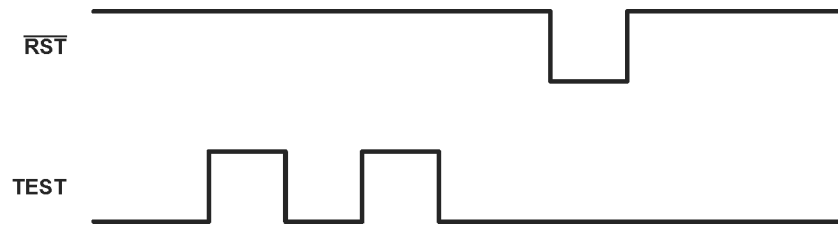
- Toggle the TEST pin twice when nRST is high and after 50us pull nRST low.

Note: This toggling of TEST pins is not subject to timing constraints. The appropriate level transitions on TEST pin, followed by a RST pulse after 50us, are sufficient to trigger an exit from BSL mode.
