ABSTRACT

This document describes the known exceptions to the functional specifications (advisories).

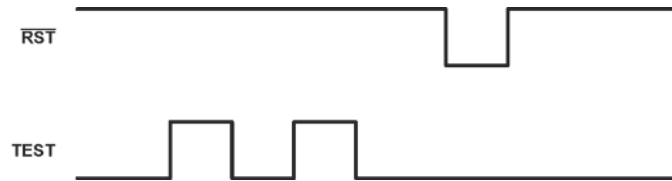
The methods used to exit the BSL per MSP430 Programming Via the Bootstrap Loader ([SLAU319](#)) are invalid.

- Workaround** To exit the BSL one of the following methods must be used.
- A Power cycle
- or
- Toggle the TEST pin twice when nRST is high and after 50us pull nRST low.

Note: This toggling of TEST pins is not subject to timing constraints. The appropriate level transitions on TEST pin, followed by a RST pulse after 50us, are sufficient to trigger an exit from BSL mode.
