MSP430F5522 Device Erratasheet

1 Functional Errata Revision History

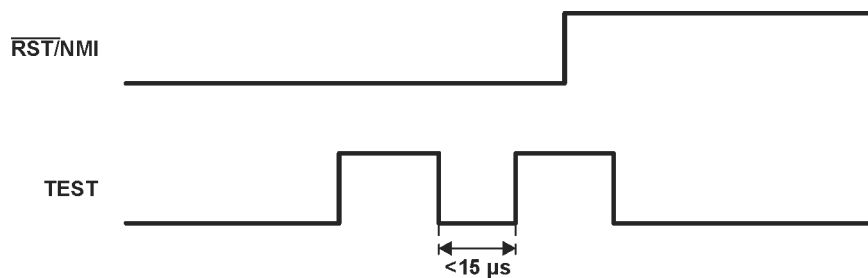
Function BSL entry sequence is subject to specific timing requirements

Description The BSL entry sequence requires that the low phase of the TEST/SBWTCK pin does not exceed 15us. This timing requirement is faster than most PC serial ports can provide, as shown in the following picture. If this requirement is not met, the entry sequence fails and the SYSBSLIND is not set.

Workaround An external hardware solution is recommended to provide the appropriate BSL entry sequence. See [http://processors.wiki.ti.com/index.php/BSL_\(MSP430\)](http://processors.wiki.ti.com/index.php/BSL_(MSP430)) for recommendations on available BSL hardware.
