ABSTRACT

This document describes the known exceptions to the functional specifications (advisories).

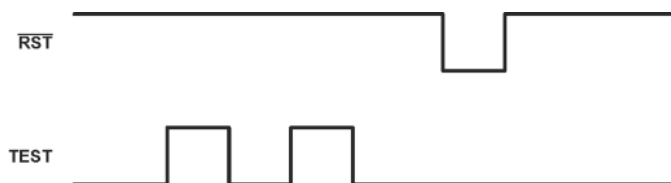
JTAG20	JTAG Module
Category	Software in ROM
Function	BSL does not exit to application code
Description	The methods used to exit the BSL per MSP430 Programming Via the Bootstrap Loader (SLAU319) are invalid.
Workaround	<p>To exit the BSL one of the following methods must be used.</p> <ul style="list-style-type: none"> - A Power cycle <p>or</p> <ul style="list-style-type: none"> - Toggle the TEST pin twice when nRST is high and after 50us pull nRST low.

Note: This toggling of TEST pins is not subject to timing constraints. The appropriate level transitions on TEST pin, followed by a RST pulse after 50us, are sufficient to trigger an exit from BSL mode.
