ABSTRACT

This document describes the known exceptions to the functional specifications (advisories).

1 Functional Advisories

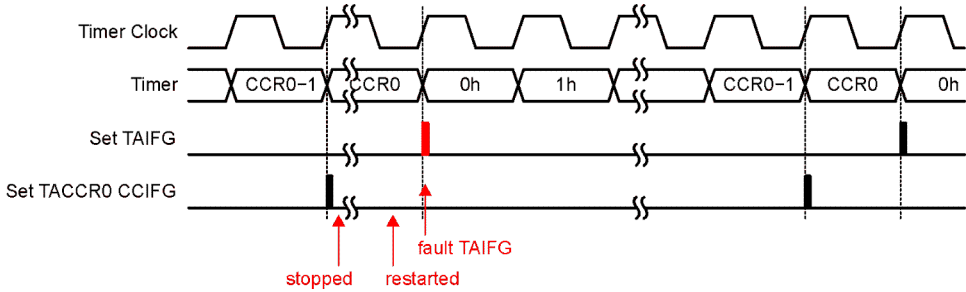
Workaround	None
TA21	TA Module
Category	Functional
Function	TAIFG Flag is erroneously set after Timer A restarts in Up Mode
Description	<p>In Up Mode, the TAIFG flag should only be set when the timer counts from TACCR0 to zero. However, if the Timer A is stopped at $TAR = TACCR0$, then cleared ($TAR=0$) by setting the TACLK bit, and finally restarted in Up Mode, the next rising edge of the TACLK will erroneously set the TAIFG flag.</p>

<p>The diagram shows four signals over time: Timer Clock, Timer, Set TAIFG, and Set TACCR0 CCIFG. The timer value starts at CCR0-1, reaches CCR0, and then 0h. It then jumps to 1h and returns to CCR0-1, then CCR0, and finally 0h. The Set TACCR0 CCIFG signal has pulses at the start of the first and third timer cycles. The Set TAIFG signal has pulses at the start of the first and third timer cycles. A red arrow labeled 'stopped' points to the first timer cycle, and a red arrow labeled 'restarted' points to the second timer cycle. A red arrow labeled 'fault TAIFG' points to the Set TAIFG pulse at the start of the second timer cycle.</p>

Workaround	None.
TAB22	TAB Module
Category	Functional
Function	Timer_A/Timer_B register modification after Watchdog Timer PUC
