MSP430FG4260 Device Erratasheet

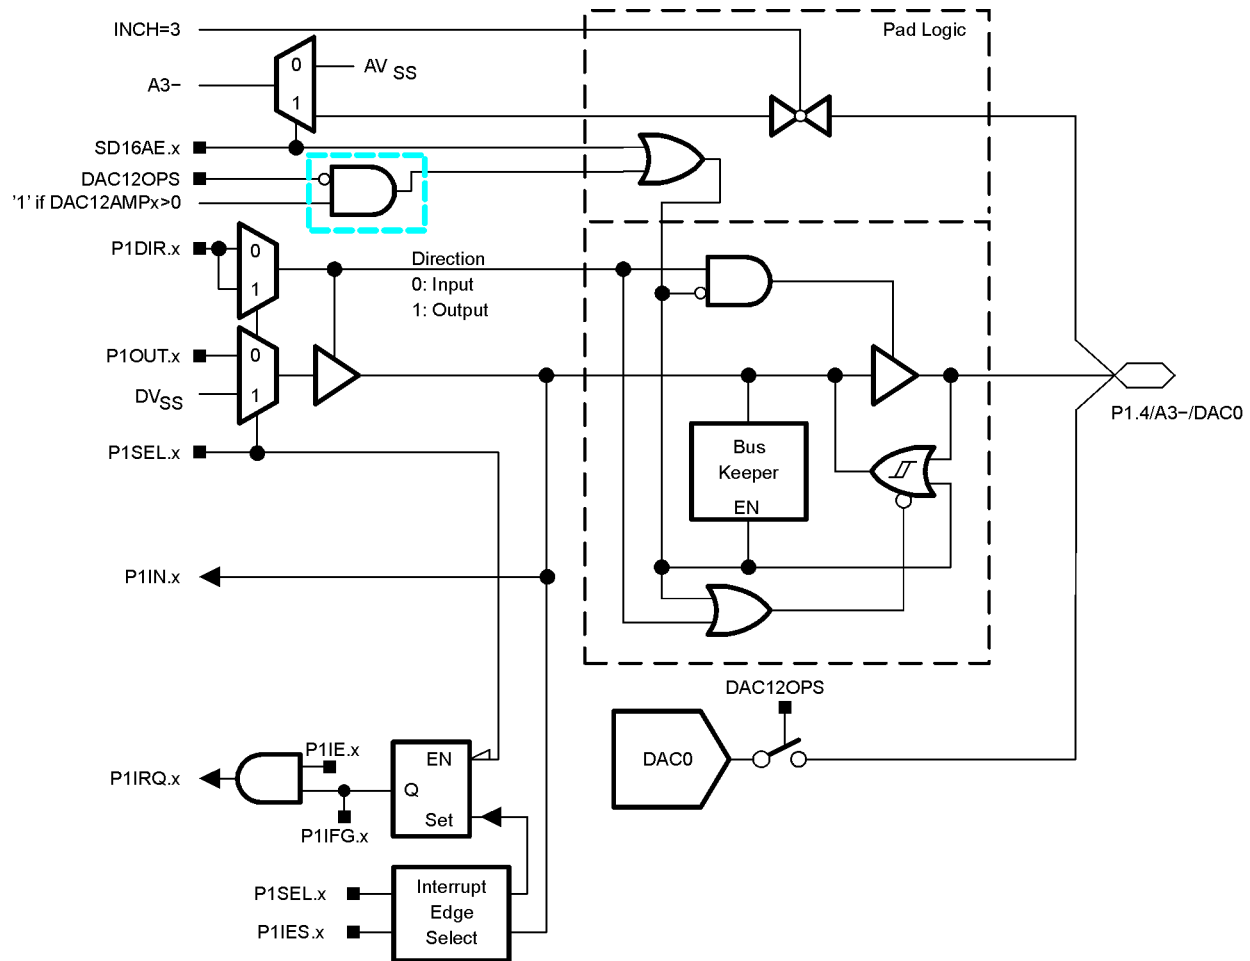
DAC2 *DAC12 Module*

Function P1.4 GPIO function is not disabled when P1.4 = DAC0 output

Description The DAC12OPS control bit used to automatically disable the P1.4 I/O logic is inverted as shown in the figure below. When DAC12 is enabled (DAC12AMPx > 0) and DAC12OPS=0, the port I/O for P1.4 will be disabled. Setting DAC12OPS = 1 to connect the DAC12 output to P1.4 will erroneously enable the port GPIO logic.

Note: x = 4

Workaround The P1.4 I/O logic should be disabled when the DAC12 is enabled using the SD16AE.4 analog enable bit. SD16AE.4=1 will disable the P1.4 I/O logic. The A3 SD16_A analog input cannot be used under this condition.

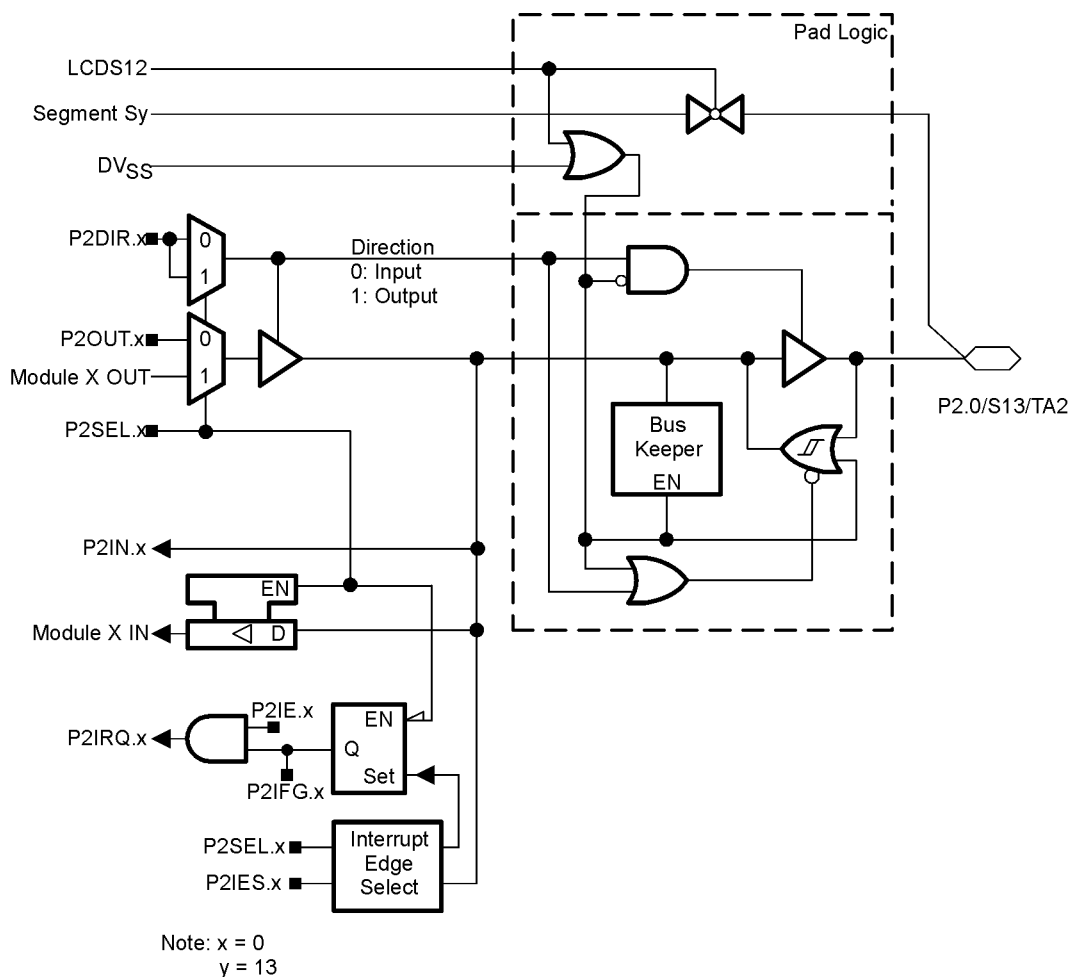
PORT6 *PORT Module*

Function P2.0 module function

Description In addition to GPIO and LCD functionality, P2.0 also has Timer_A3 module output capability. When $\text{P2SEL.0} = 1$ and $\text{P2DIR.0} = 1$, P2.0 becomes a TA2 output.

PIN NAME (P2.X)	X	FUNCTION	CONTROL BITS / SIGNALS		
			P2DIR.x	P2SEL.x	LCDS12
P2.0/S13/TA2	0	P2.0 Input/Output	0/1	0	0
		N/A	0	1	0
		Timer_A3.TA2	1	1	0
		S13	X	X	1
