MSP430FG438 Device Erratasheet

1 Functional Errata Revision History

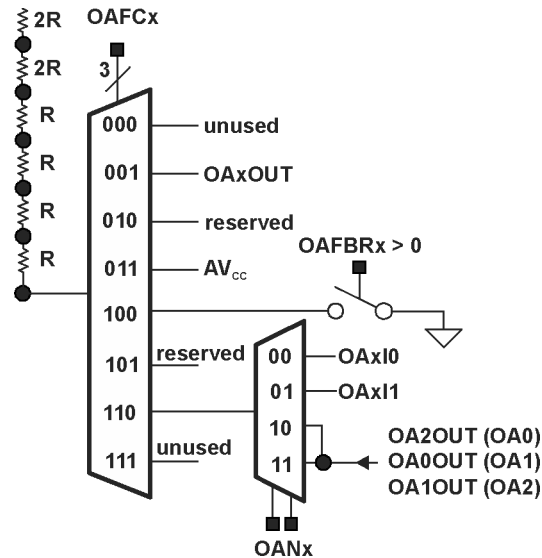
OA1	OA Module
Category	Functional
Function	OAxI1 input selection
Description	Referring to the OA block diagram in the MSP430x4xx User's Guide, the internal connection of the OAxI1 input to the OAFcX mux is incorrect. The signal input to the OAFcX mux when OANx = 01 is OA0I1 for all OAs. See the figure below for a graphical representation.

Workaround	None
TA12	TIMER_A Module
Category	Functional
Function	Interrupt is lost (slow ACLK)
Description	Timer_A counter is running with slow clock (external TACLK or ACLK) compared to MCLK. The compare mode is selected for the capture/compare channel and the CCRx register is incremented by one with the occurring compare interrupt (if TAR = CCRx). Due to the fast MCLK the CCRx register increment (CCRx = CCRx+1) happens before the Timer_A counter has incremented again. Therefore the next compare interrupt should happen at once with the next Timer_A counter increment (if TAR = CCRx + 1). This interrupt gets lost.
Workaround	Switch capture/compare mode to capture mode before the CCRx register increment. Switch back to compare mode afterwards.
TA16	TIMER_A Module
Category	Functional
Function	First increment of TAR erroneous when IDx > 00
Description	The first increment of TAR after any timer clear event (POR/TACLK) happens

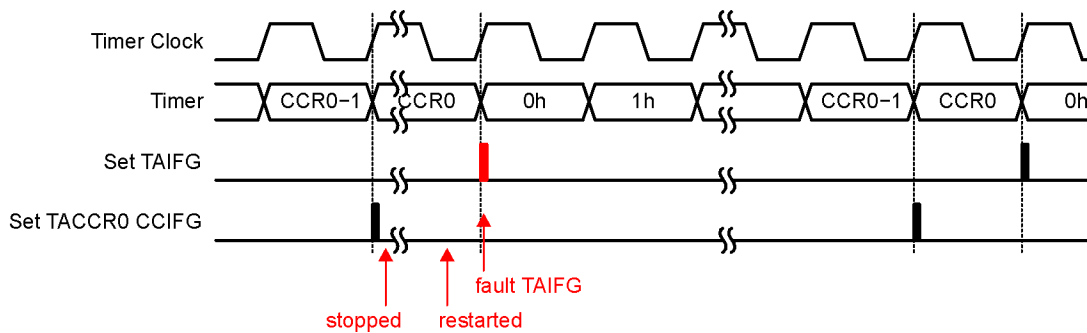
Function TAIFG Flag is erroneously set after Timer A restarts in Up Mode

Description In Up Mode, the TAIFG flag should only be set when the timer counts from TACCR0 to zero. However, if the Timer A is stopped at TAR = TACCR0, then cleared (TAR=0) by setting the TACLRL bit, and finally restarted in Up Mode, the next rising edge of the TACLK will erroneously set the TAIFG flag.

Workaround None.

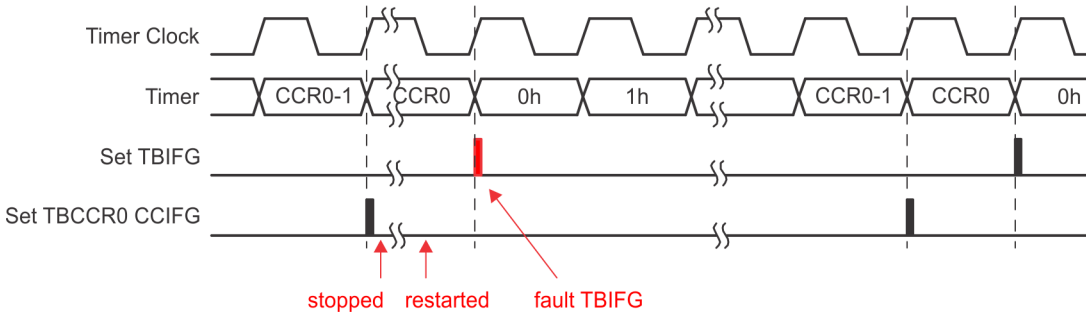
Workaround	None
TB24	TIMER_B Module
Category	Functional
Function	TBIFG Flag is erroneously set after Timer B restarts in Up Mode
Description	<p>In Up Mode, the TBIFG flag should only be set when the timer resets from TBCCR0 to zero. However, if the Timer B is stopped at $TBR = TBCCR0$, then cleared ($TBR=0$) by setting the TBCLR bit, and finally restarted in Up Mode, the next rising edge of the TBCLK will erroneously set the TBIFG flag.</p>

Workaround	None.
