MSP430FG439 Device Erratasheet

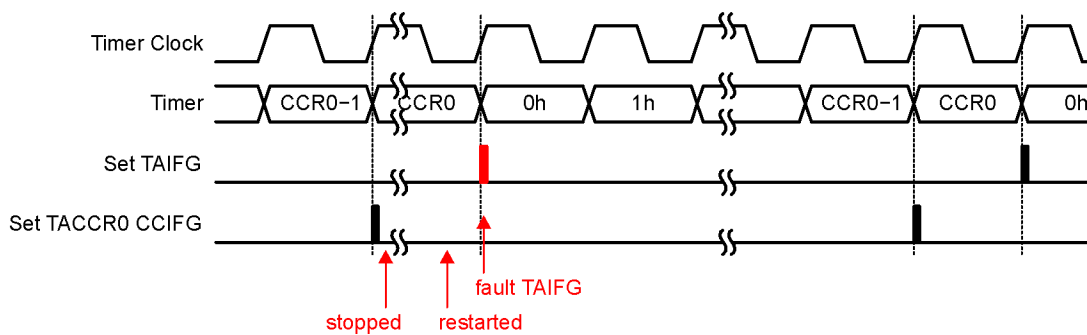
TA21 *TIMER_A Module*

Function TAIFG Flag is erroneously set after Timer A restarts in Up Mode

Description In Up Mode, the TAIFG flag should only be set when the timer counts from TACCR0 to zero. However, if the Timer A is stopped at TAR = TACCR0, then cleared (TAR=0) by setting the TACLRL bit, and finally restarted in Up Mode, the next rising edge of the TACLK will erroneously set the TAIFG flag.

Workaround None.
