MSP430FG4616 Device Erratasheet

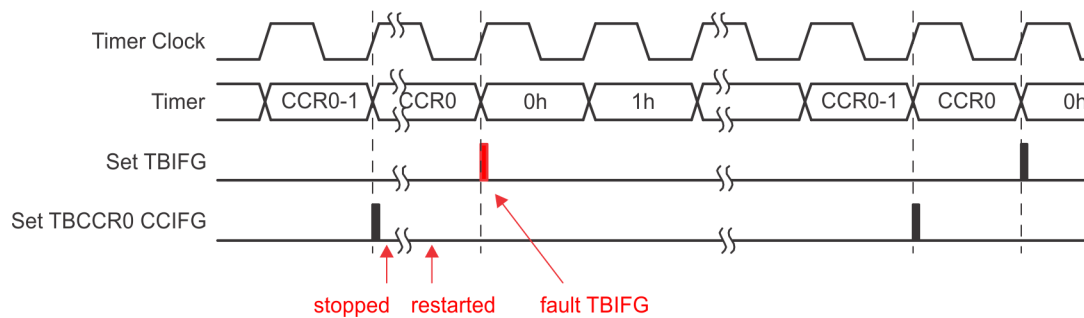
Workaround	None
TB18	<i>TIMER_B Module</i>
Category	Functional
Function	MOV to TBCTL may clear TBRTB18 TB18 - Bug
Description	When TBCTL is modified with a MOV instruction, the contents of TBR may be cleared, even when TBCLR is not set.
Workaround	Use BIS or BIC instructions to modify TBCTL.
	<p>NOTE: A DMA transfer must not occur while these BIS and BIC instructions execute. This can be prevented by disabling the DMA prior to these instructions or by using the DMAONFETCH bit to align DMA transfers to instruction fetch boundaries.</p>
TB24	<i>TIMER_B Module</i>
Category	Functional
Function	TBIFG Flag is erroneously set after Timer B restarts in Up Mode
Description	In Up Mode, the TBIFG flag should only be set when the timer resets from TBCCR0 to zero. However, if the Timer B is stopped at TBR = TBCCR0, then cleared (TBR=0) by

setting the TBCLR bit, and finally restarted in Up Mode, the next rising edge of the TBCLK will erroneously set the TBIFG flag.

None.
