## MSP430FG4619 Device Erratasheet

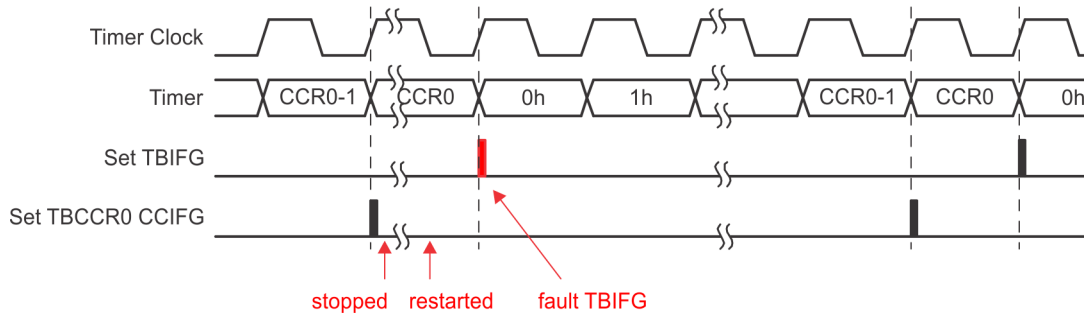
**TB24** *TIMER\_B Module*

**Function** TBIFG Flag is erroneously set after Timer B restarts in Up Mode

**Description** In Up Mode, the TBIFG flag should only be set when the timer resets from TBCCR0 to zero. However, if the Timer B is stopped at TBR = TBCCR0, then cleared (TBR=0) by setting the TBCLR bit, and finally restarted in Up Mode, the next rising edge of the TBCLK will erroneously set the TBIFG flag.

**Workaround** None.
