MSP430G2213 Device Erratasheet

6 Detailed Bug Description

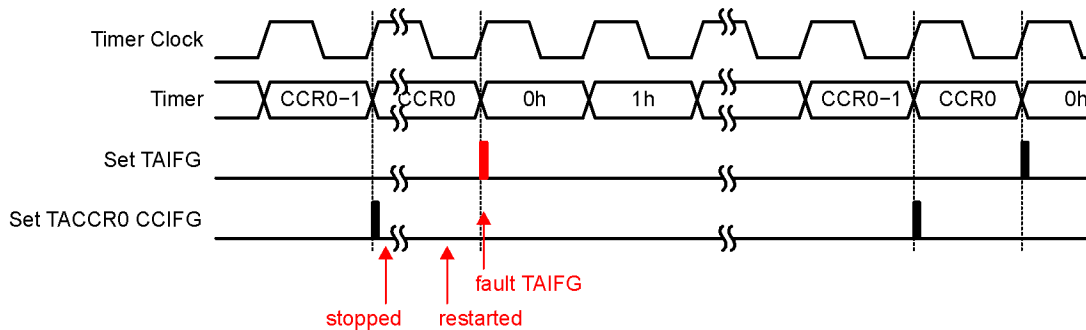
TA21 *TIMER_A Module*

Function TAIFG Flag is erroneously set after Timer A restarts in Up Mode

Description In Up Mode, the TAIFG flag should only be set when the timer counts from TACCR0 to zero. However, if the Timer A is stopped at TAR = TACCR0, then cleared (TAR=0) by setting the TACLR bit, and finally restarted in Up Mode, the next rising edge of the TACLK will erroneously set the TAIFG flag.

Workaround None.
