MSP430G2233 Device Erratasheet

1 Functional Errata Revision History

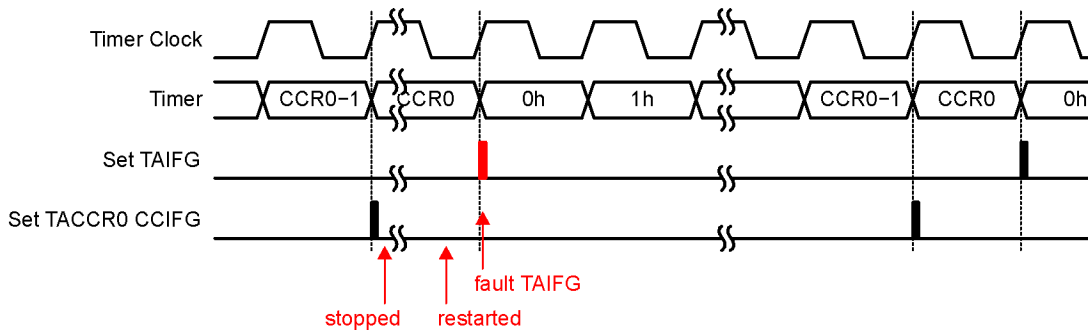
TA21 *TIMER_A Module*

Function TAIFG Flag is erroneously set after Timer A restarts in Up Mode

Description In Up Mode, the TAIFG flag should only be set when the timer counts from TACCR0 to zero. However, if the Timer A is stopped at TAR = TACCR0, then cleared (TAR=0) by setting the TACLr bit, and finally restarted in Up Mode, the next rising edge of the TACLK will erroneously set the TAIFG flag.

Workaround None.
