MSP430F5338 Device Erratasheet

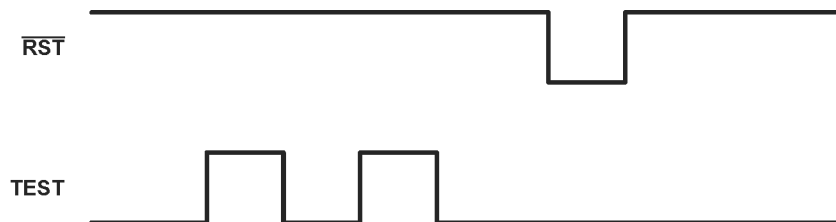
- A Power cycle
- or
- Toggle the TEST pin twice when nRST is high and after 50us pull nRST low.

Note: This toggling of TEST pins is not subject to timing constraints. The appropriate level transitions on TEST pin, followed by a RST pulse after 50us, are sufficient to trigger an exit from BSL mode.

| Workaround | To exit the BSL one of the following methods must be used. |
