MSP430G2544 Device Erratasheet

1 Functional Errata Revision History

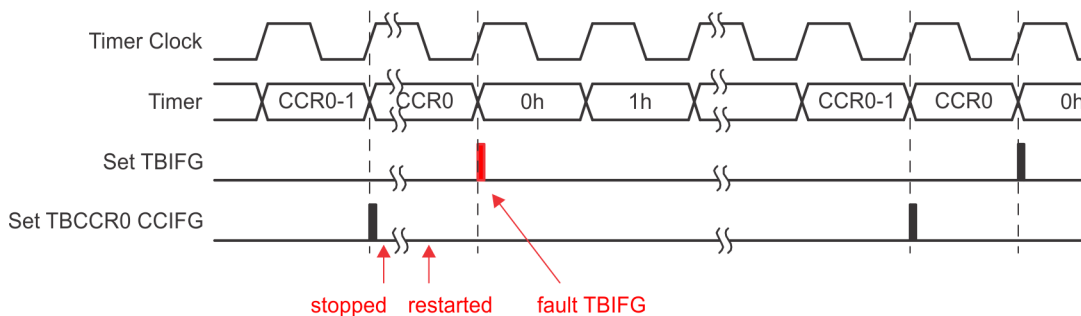
TB24 *TIMER_B Module*

Function TBIFG Flag is erroneously set after Timer B restarts in Up Mode

Description In Up Mode, the TBIFG flag should only be set when the timer resets from TBCCR0 to zero. However, if the Timer B is stopped at TBR = TBCCR0, then cleared (TBR=0) by setting the TBCLR bit, and finally restarted in Up Mode, the next rising edge of the TBCLK will erroneously set the TBIFG flag.

Workaround None.
