# MSP430G2444 Device Erratasheet

## 1 Functional Errata Revision History

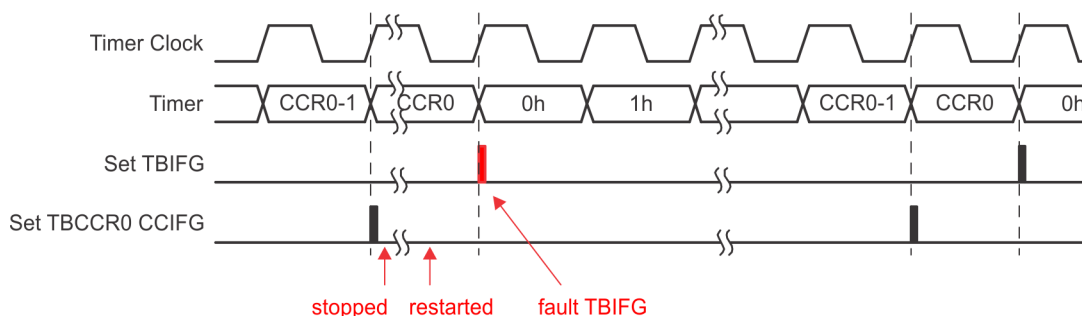
**TB24** *TIMER\_B Module*
**Category** Functional

**Function** TBIFG Flag is erroneously set after Timer B restarts in Up Mode

**Description** In Up Mode, the TBIFG flag should only be set when the timer resets from TBCCR0 to zero. However, if the Timer B is stopped at  $TBR = TBCCR0$ , then cleared ( $TBR=0$ ) by setting the TBCLR bit, and finally restarted in Up Mode, the next rising edge of the TBCLK will erroneously set the TBIFG flag.

**Workaround** None.
