ERRATA FOR IEEE 1394b THREE-PORT CABLE TRANSCEIVER/ ARBITER TSB81BA3, TSB81BA3I (SLLS559) AND TSB81BA3-EP (SGLS194)

SLLZ015C – DECEMBER 2002 – REVISED MARCH 2006

TSB81BA3 Silicon Errata

This document contains corrections and additions to the following device data sheets: TSB81BA3 (TI Literature Number SLLS559) and TSB81BA3-EP (TI Literature Number SGLS194).

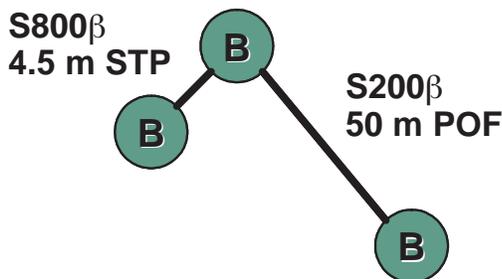
Figure 1. BOSS Arbitration Issue Caused By Mixed Cable Lengths

2. BOSS arbitration issue	<p><u>Symptom</u> A bus-reset may occur in certain topologies when 1394b BOSS arbitration is in use.</p> <p><u>Occurrences</u> This issue is only possible if three or more BOSS-arbitration capable nodes are connected through a 1394b connection. To be BOSS-arbitration capable a node must have a 1394b PHY and a 1394b Link using the 1394b PHY-Link interface connection.</p> <p>If a narrow timing window is violated (dependent on cable lengths and/or mixed speed bus hops) a middle node may detect a packet collision, causing a PHY state timeout. The state timeout causes a bus reset. Repetitive occurrences result in repetitive bus resets.</p> <p><u>Example Topologies</u> A. Mixing short and long cable lengths. A BOSS arbitration issue may occur in the middle node. Figure 1 shows an example topology that would exhibit the condition.</p>	<p>A. Use one or more 1394a link-layer controllers (LLCs). If the network only consists of nodes using 1394a link layers, then BOSS arbitration is not utilized; Gap_Count delays are maintained and therefore nodes are not affected by this errata.</p> <p>B. In nodes that do not have a link, disable BOSS arbitration (e.g., force the BMODE pin to the logic 0 state).</p> <p>C. Use a topology where all nodes use the same 1394a compatible bus speed (e.g., S400) and at least one IEEE Std 1394a-2000 node is present.</p> <p>D. Use a topology where all 1394B nodes are at the same 1394b bus speed, using matched cable lengths between 1M and 4.5M.</p>

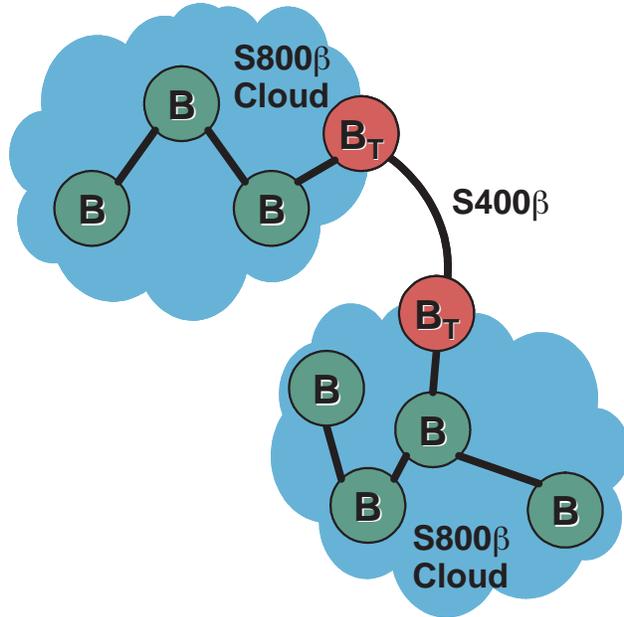
Figure 2. BOSS Arbitration Issue Caused By Mixed Bus Hop Speeds

SILICON ERRATA ID	PROBLEM DESCRIPTION	RESOLUTION / WORK-AROUNDS
2. BOSS arbitration issue (continued)	<u>Example Topologies</u> (continued) B. Mixing bus hop speeds. Either transition node (B_T) may have a BOSS arbitration issue. See Figure 2.

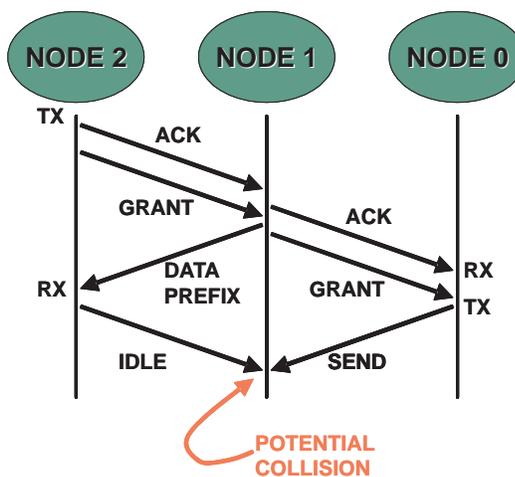
Figure 3. BOSS Arbitration Issue—Detailed Example Situation

SILICON ERRATA ID	PROBLEM DESCRIPTION	RESOLUTION / WORK-AROUNDS
2. BOSS arbitration issue (continued)	<p><u>Detailed Example Situation</u> See Figure 3.</p> <ol style="list-style-type: none"> 1. Node #2 transmits a high-speed packet that ends an Async subaction or the Isoch period. 2. Node #2 advances the Async phase (no requests pending for the current phase). 3. Node #0 has a bus request pending for the new phase. 4. Node #2 sends an Async grant. 5. The Async grant is forwarded through a senior node (Node #1) and down through a junior connection to Node #0. 6. If a narrow timing window is violated the middle node (Node #1) will detect a packet collision, causing a state-timeout while forwarding the grant to the next node. The state-timeout will cause a bus reset.
