UCD3138 Integrated Power Controller Family Errata

This document describes the known exceptions to functional specifications (advisories) for the UCD3138 integrated digital power controller family of devices.

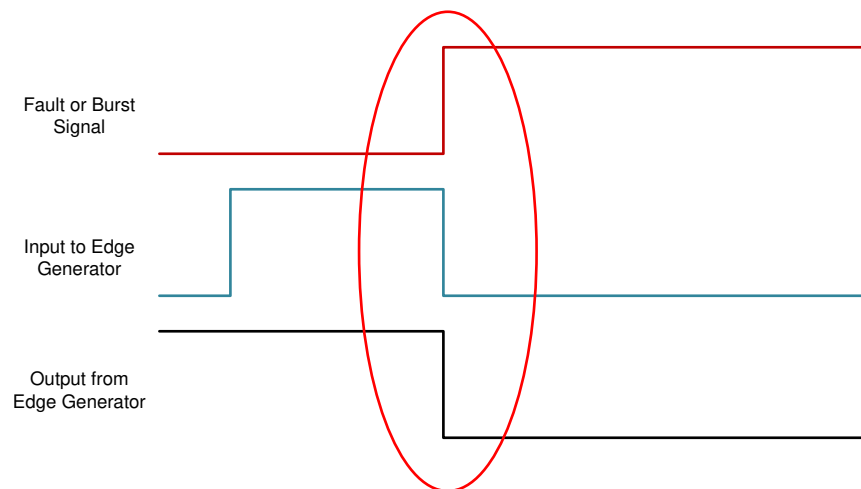
Figure 2. Fault or Burst Turns DPWM OFF

Some PSFB signals go low on a falling edge input. Fault will make all Edge Generation inputs go low. If the relevant input is high, the output will go low, so fault is handled as expected – [Figure 2](#).

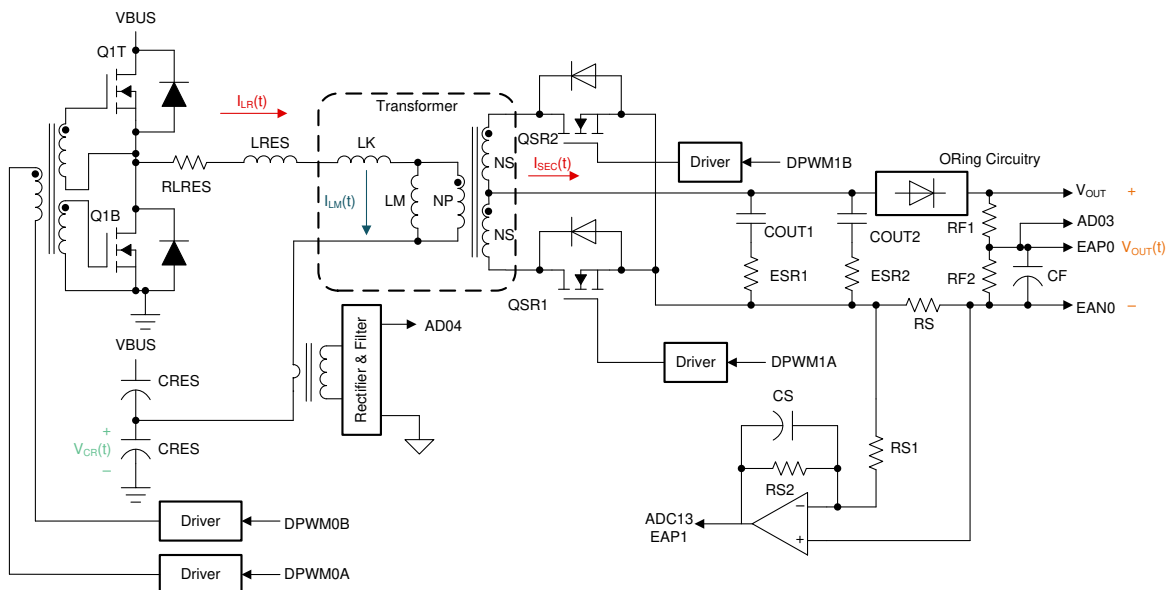
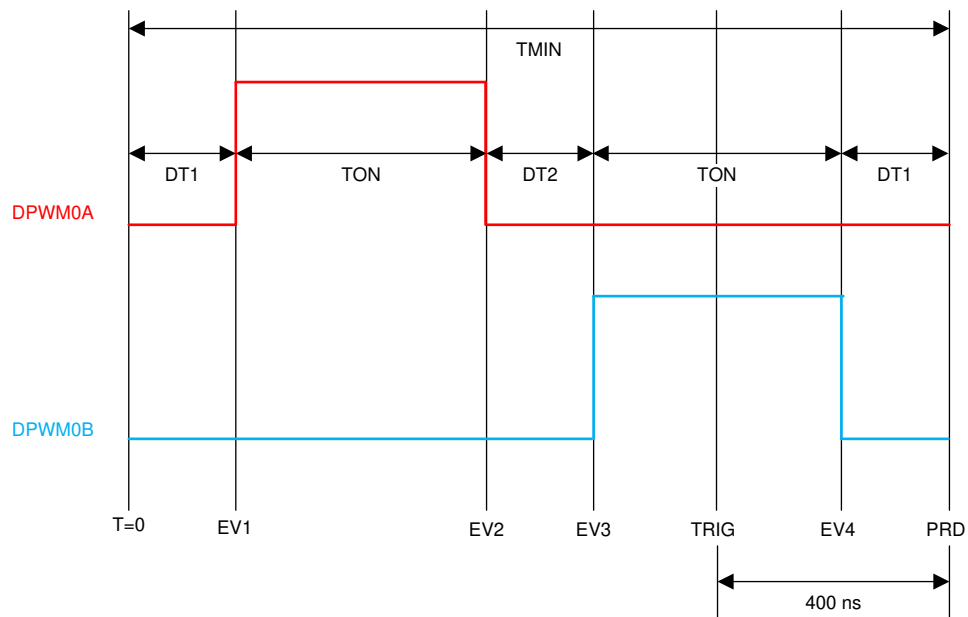
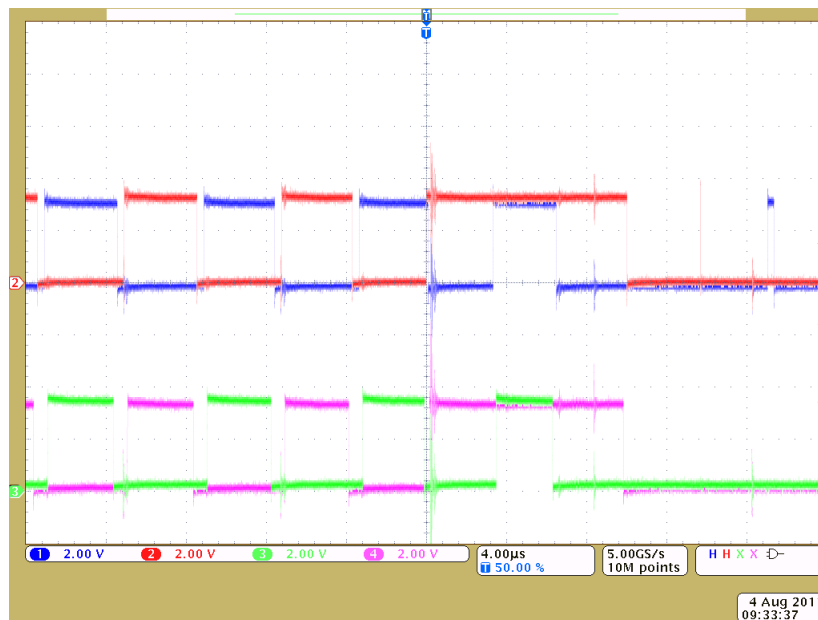
DPWM pulse extension in the LLC converter can occur under the following conditions, (1) the sample trigger is within 400 ns of the end of the frame, and (2) there is a large change in Y_N such that the converter transitions from multi-mode to resonant mode operation.

Place the sample trigger (TRIG) near the beginning of the period or no later than 400 ns from the end of the shortest period that must be supported.
