## Stellaris® LM3S9B90 RevB1 Errata

This document contains errata as of October 2013 for the Stellaris LM3S9B90 microcontroller. Additional errata added after October 2013 that apply to revision B1 can be found in the *Stellaris® LM3S Tempest- and Firestorm-Class Microcontrollers Errata* ([SPMZ861](#)). Read both documents for the complete list of errata for your device.

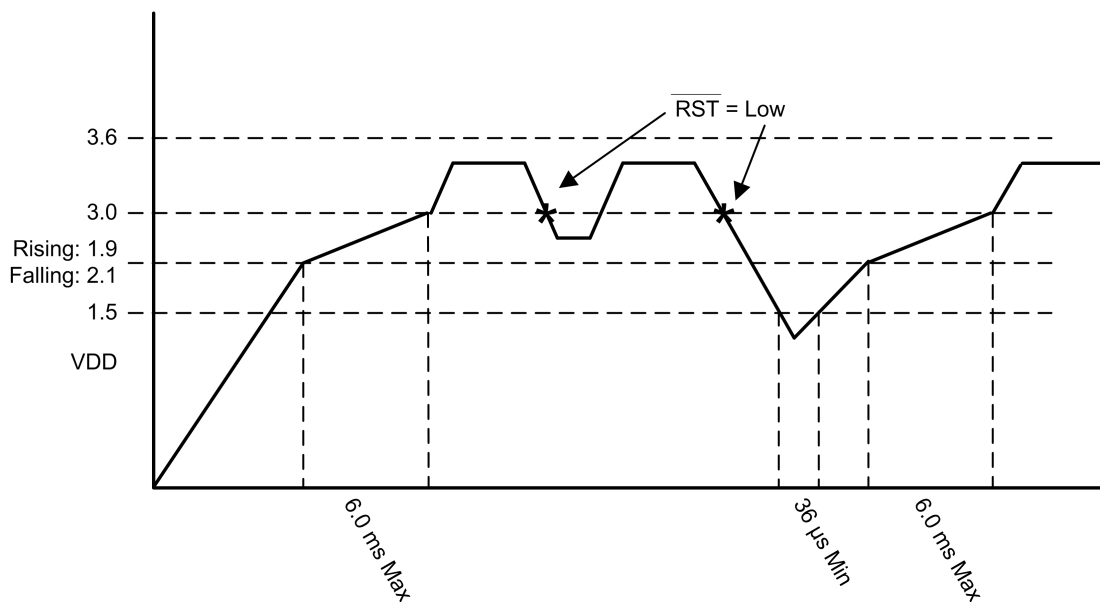
**Figure 1. VDD Waveform Signature Limits**

Depending on the system environment requirement, items 3, 4, and 5 in the above list may be met by using a voltage supervisor, such as the TLV803M, to monitor a higher voltage rail from which the VDD supply is regulated. Figure 2 on page 15 shows this implementation with a voltage supervisor monitoring the 5-V rail and a voltage trip point of 4.38 V. A voltage supervisor with a lower voltage trip point can be used to monitor the VDD (3.3-V) rail, however this supervisor must assert reset before VDD reaches 3.0 V. Regardless of the implemented voltage supervisor circuit, the system designer must ensure that there is enough time to assert RST Low prior to VDD falling below 3.0 V. Figure 3 on page 15 shows the resulting waveform of the circuit shown in Figure 2 on page 15.

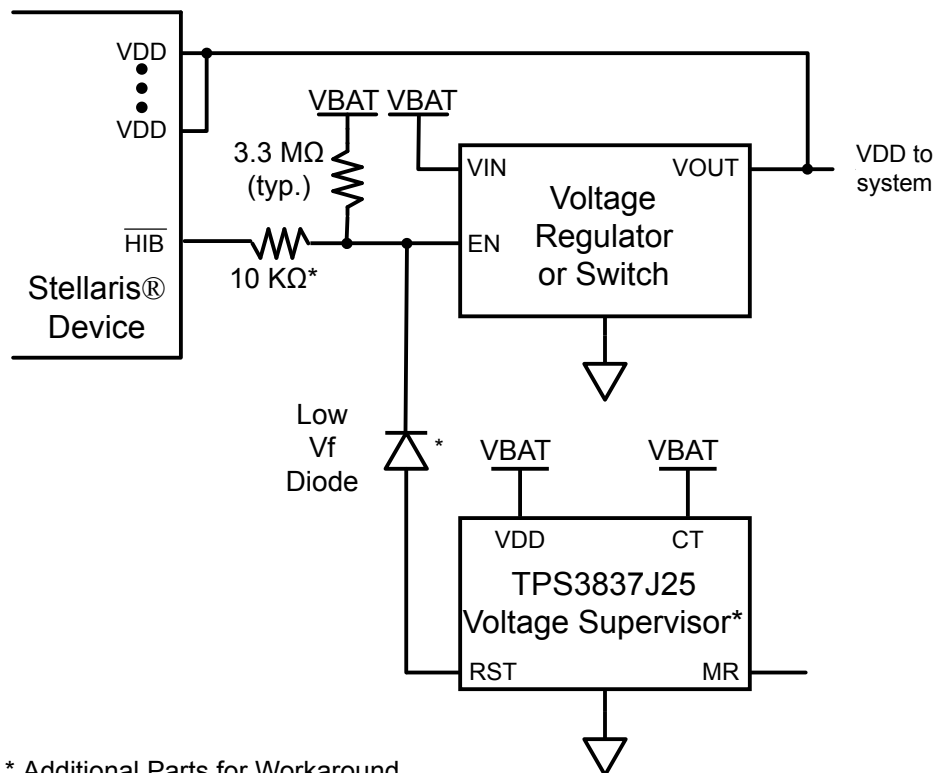
Figure 5. Workaround Circuit to Ensure Initial Power Up

If  $V_{DD}$  is not powered when voltage is first applied to  $V_{BAT}$ , the state of the Hibernation module is indeterminate and the HIB signal may be asserted. In this indeterminate state, a lock condition can occur in which the Hibernation module waits for a power-on-reset, but that reset cannot occur until the module deasserts HIB. This issue is related to the errata "Hibernation module may have higher current draw than specified in data sheet under certain conditions" on page 17.

The workaround implementation depends on the system-level power supply configuration. For systems that use a battery as the primary power source, an external voltage supervisor (TPS383J25DBV or similar) circuit can be added to force the  $V_{DD}$  power supply to start when the battery voltage is first applied (see Figure 5). The voltage supervisor requires only 220 nA and generates a 200-ms positive pulse to turn on the  $V_{DD}$  regulator and activate the microcontroller's internal POR circuit.

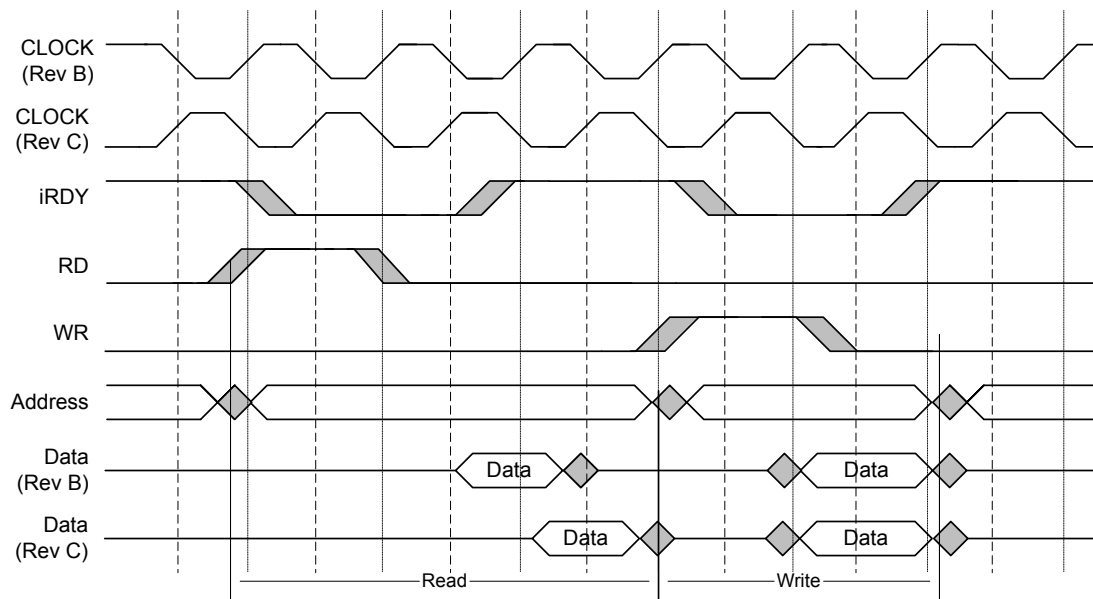
**Figure 6. Timing Differences Between Rev B and Rev C Devices**

The clock signal that is output on the EPI0S31 signal in General-Purpose mode is inverted. Figure 6 on page 31 shows the timing differences between Rev B parts and Rev C parts.

Use the opposite edge for timing when designing with this interface. During read cycles, ensure that the data meets set up and hold times for the appropriate edge as shown in the diagram above.

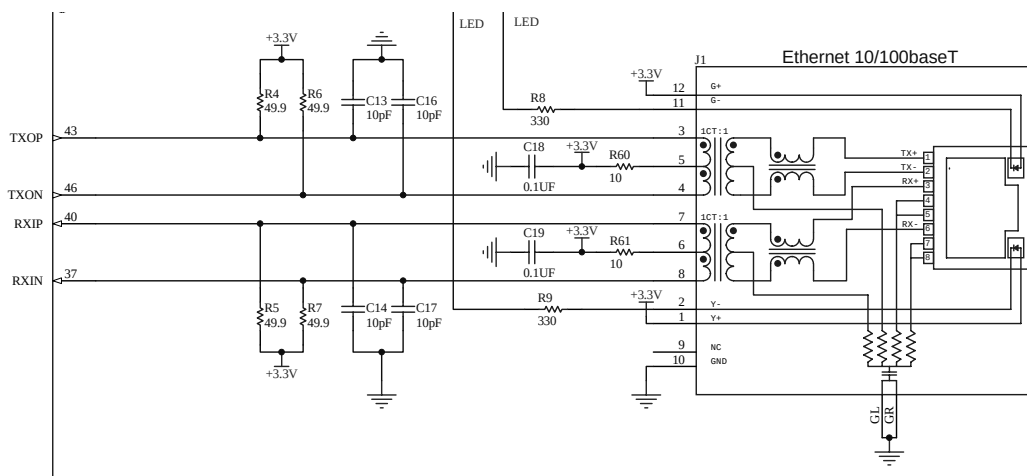
**Figure 8. Recommended Center-Tap Connections**

The microcontroller experiences some packet loss with Ethernet cables longer than 50 meters in normal operating conditions.

1. Add 10  $\Omega$  resistor to the center-tap of the transformer as shown in the figure. These resistors should be replaced by a direct connection for silicon that has this item fixed.
2. Continue using the recommended circuit, but limit cable lengths to 50 meters.

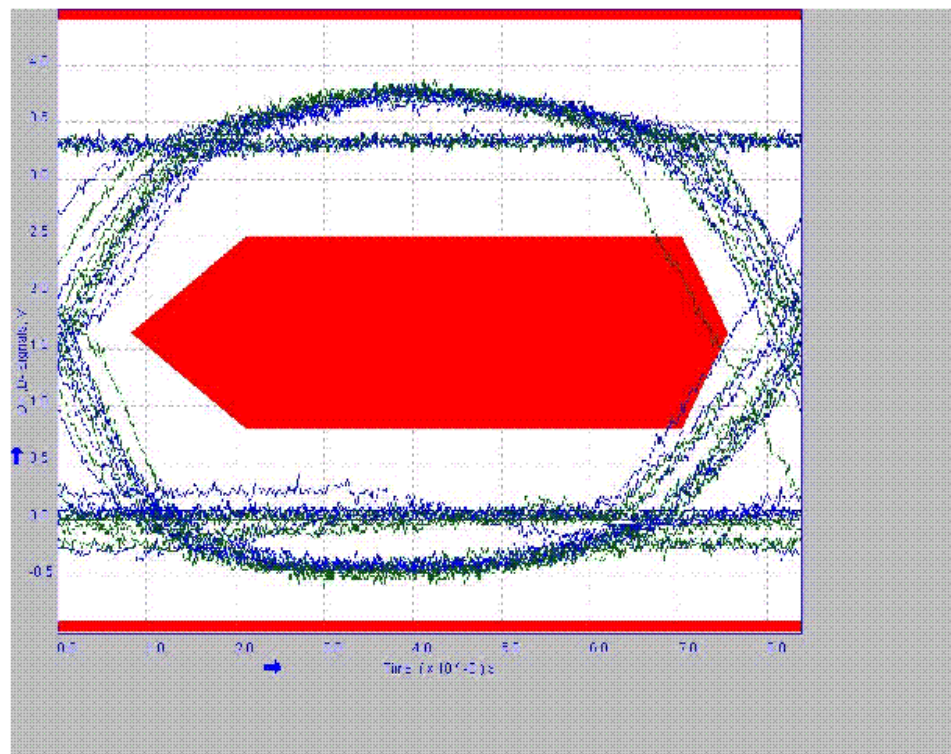
**Figure 9. Example of USB Certification Failure**

If the EPI module is operating, the USB interface may fail USB certification. Failures have been seen for the eye diagram and jitter (see Figure 9 on page 54). Because of these issues, there is a potential for data corruption on the USB interface when using the USB and EPI at the same time. The risk of data corruption is small, but is dependent on the system design.

- Signal eye:  
Eye Diagram Test fails

- EOP width: 169.0995ns  
EOP width passes
- Receivers: reliable operation on tier Tier 6  
Receivers pass
- Measured Signalling Rate: 11.92707Mbps  
signal rate conditionally passes
- Crossover voltage range: 1.546667 V to 1.680000 V  
Mean crossover = 1.615889 V  
First crossover at 1.660000 V(11 other differential crossovers checked)  
crossover voltages pass
- Consecutive jitter range: -165.1885ns to 1.811468ns, RMS jitter 52.27256ns  
Paired JK jitter range: 752.3810ps to 2.871429ns, RMS jitter 1.821542ns  
Paired KJ jitter range: 1.185714ns to 2.168571ns, RMS jitter 1.695397ns  
jitter fails

USB certification can be attained if an application does not require the USB and the EPI to be operating simultaneously. Customers who do not intend to pursue USB certification should determine if their application can handle the resulting small amount of error.

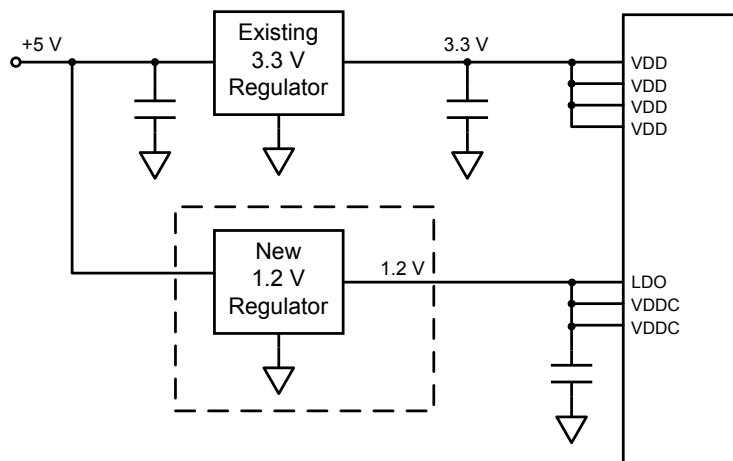
**Figure 14. Configuration of External Regulator**

Incorrect power sequencing during power up can disrupt operation and potentially cause device failure.

$V_{DDC}$  must be applied approximately 50  $\mu$ s before  $V_{DD}$ . Normally  $V_{DDC}$  is controlled by the part's internal LDO voltage regulator. The workaround requires the addition of an external regulator (see Figure 14) to ensure that  $V_{DDC}$  sequencing requirements are met (see Figure 15). A recommended regulator is the TI TPS73101DBVR.

This fix mitigates the on-chip power issue, but does not solve it completely. During development, the Flash memory should also be reprogrammed (using LMFlash or another programming tool) at least once a week.
