## Stellaris® LM4F110E5QR Rev A1/A3/B0 Errata

**Note:** The Stellaris LM4F110E5QR microcontroller has been replaced by the identical Tiva™ C Series TM4C1231E6PM microcontroller.

This document contains known errata at the time of publication for the Stellaris LM4F110E5QR microcontroller, revisions A1, A3, and B0. Additional errata that applies to revisions A1, A3, and B0, as well as revisions following B0 can be found in *Stellaris® LM4F Microcontrollers Silicon Revisions 6 and 7 Errata (SPMZ856)*. Read both documents for a complete list of errata for your device.

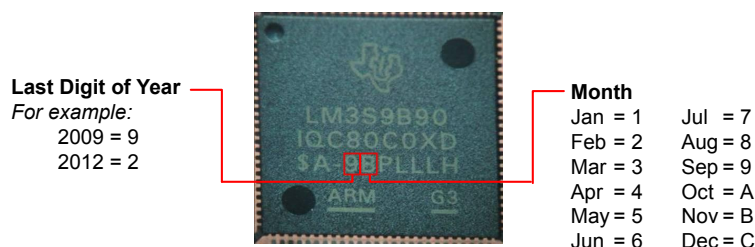
The Precision Internal Oscillator (PIOSC) is untrimmed on some devices during factory test prior to shipment. The PIOSC on untrimmed devices has an error of up to  $\pm 10\%$ . Normally the PIOSC is trimmed to  $16\text{ MHz} \pm 1\%$  at room temperature and  $16\text{ MHz} \pm 3\%$  across the operating temperature range.

**Note:** To determine the date code of your part, look at the first two characters following the dash on the third line of the part markings (highlighted in red in the following figure). The first number after the dash indicates the last decimal digit of the year. The second character indicates the month. Therefore, the following example shows a date code of 9B which indicates November 2009.

The PIOSC can be trimmed by the user in one of two ways: automatically with the Hibernation module, and manually with a user-defined calibration value based on another clock source.

Fixed on devices with date codes of 0x21 (January, 2012) or later. Fixed on all A3 devices.
