Stellaris® LM4F230H5QR Rev A1/A3/B0 Errata

Note: The Stellaris LM4F230H5QR microcontroller has been replaced by the identical Tiva™ C Series TM4C123GH6PM microcontroller.

This document contains known errata at the time of publication for the Stellaris LM4F230H5QR microcontroller, revisions A1, A3, and B0. Additional errata that applies to revisions A1, A3, and B0, as well as revisions following B0 can be found in *Stellaris® LM4F Microcontrollers Silicon Revisions 6 and 7 Errata (SPMZ856)*. Read both documents for a complete list of errata for your device.

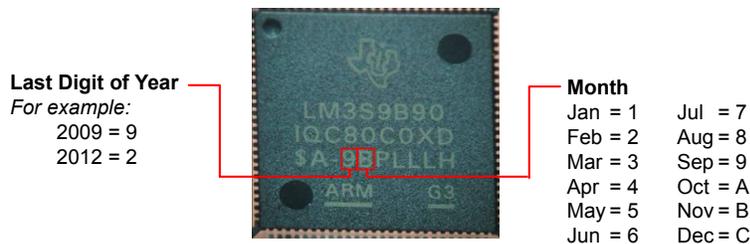
Note: To determine the date code of your part, look at the first two characters following the dash on the third line of the part markings (highlighted in red in the following figure). The first number after the dash indicates the last decimal digit of the year. The second character indicates the month. Therefore, the following example shows a date code of 9B which indicates November 2009.
