## Stellaris<sup>®</sup> LM3S6G11 RevA2 Errata

This document contains known errata at the time of publication for the Stellaris LM3S6G11 microcontroller. The table below summarizes the errata and lists the affected revisions. See the data sheet for more details.

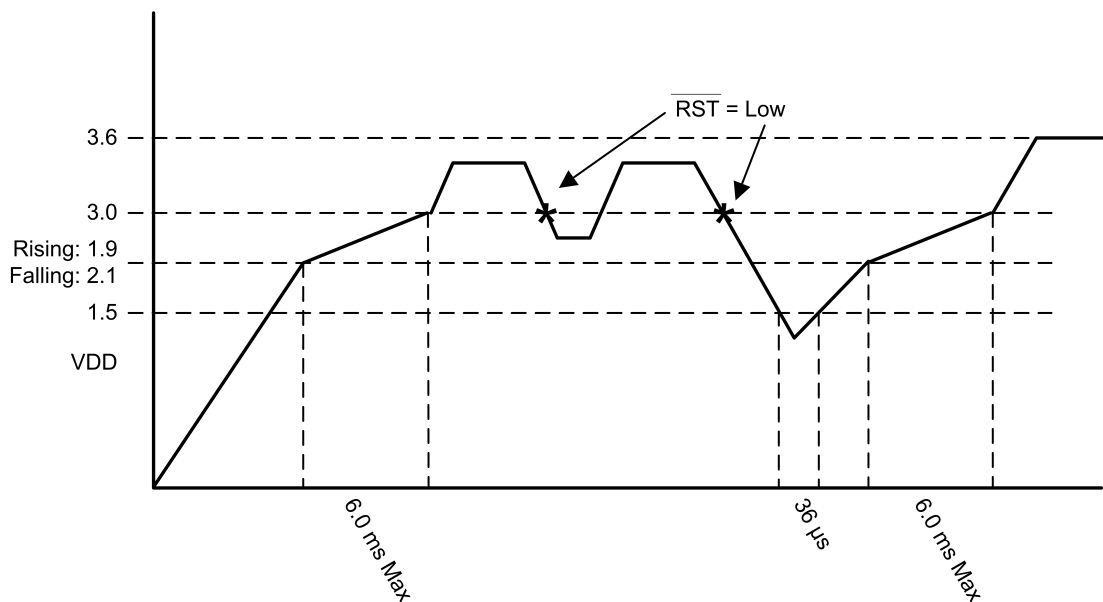
**Figure 1. VDD Waveform Signature Limits**

The Power-On Reset gap occurs because the supervisor can release internal state machine operation as soon as 6.0 ms after the VDD supply reaches 1.9 V. If VDD is still below the minimum operating voltage of 3.0 V after 6.0 ms, the power-up state machine may not function correctly, resulting in the effects described above. The  $\overline{\text{RST}}$  pin of the device has no effect on the initialization state machine, therefore, a complete power-cycle is required to restore the initialization state machine.

The Brown-Out Reset threshold ( $V_{\text{BTH}}$ ) gap occurs because the brown-out supervisor has a threshold as low as 2.85 V, which is less than the minimum operating voltage on VDD, and also because it can take several microseconds to respond. BOR gaps can be encountered after power up, during steady state operation power-on, if the VDD rail has glitches, and also during power-down.

After initial power-up, any processor operation with VDD below 3.0 V may result in unexpected code execution resulting in the effects described above. The processor must be halted or the  $\overline{\text{RST}}$  signal must be driven Low prior to VDD dropping below 3.0 V and stay in that state until VDD is above 3.0 V.

If VDD falls below 2.1 V, it must continue to fall until it reaches 1.5 V. VDD must stay below 1.5 V for at least 36  $\mu\text{s}$  to ensure that a POR is triggered correctly. Additionally, the VDD power-up time between 1.9 V and 3.0 V must be at most 6.0 ms. If VDD falls below 3.0 V but stays above 2.1 V, it is not necessary for the voltage to continue falling below 2.1 V. VDD can come back up to 3.0 V without any additional timing requirements.

1. The VDD power-up, steady state, and power-down waveform meets the timing requirements shown in Figure 1 on page 11.
