## Stellaris<sup>®</sup> LM3S6C11 RevA2 Errata

This document contains known errata at the time of publication for the Stellaris LM3S6C11 microcontroller. The table below summarizes the errata and lists the affected revisions. See the data sheet for more details.

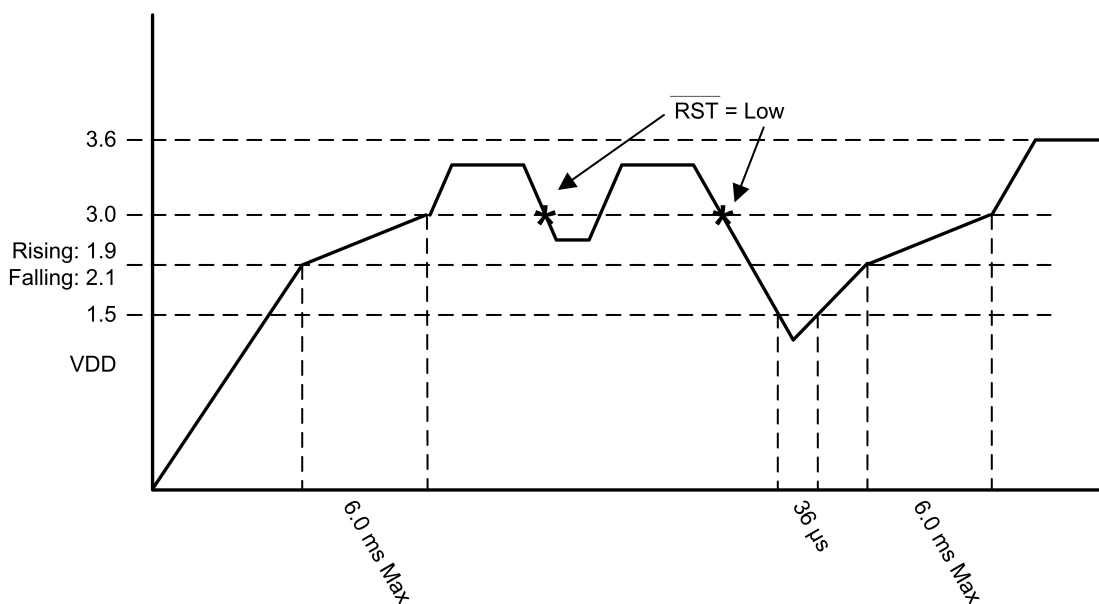
**Figure 1. VDD Waveform Signature Limits**

This microcontroller incorporates internal Power-On Reset (POR) and Brown-Out Reset (BOR) supervisors to ensure that code only executes when power to the device is within specification. However, gaps in the voltage and timing thresholds of the internal supervisors result in a risk of incorrect operation during VDD power transitions.

Unexpected operation may occur that can include brief execution of random sections of user code including ROM functions and random instructions, as well as incorrect power-up initialization. The uncontrolled brief execution of random instructions may result in the undesired erasing or writing of non-volatile memories and GPIO state changes. There is also the possibility that the device may be left in a state where it does not operate correctly until a clean power cycle has been completed.

The Power-On Reset gap occurs because the supervisor can release internal state machine operation as soon as 6.0 ms after the VDD supply reaches 1.9 V. If VDD is still below the minimum operating voltage of 3.0 V after 6.0 ms, the power-up state machine may not function correctly, resulting in the effects described above. The  $\overline{\text{RST}}$  pin of the device has no effect on the initialization state machine, therefore, a complete power-cycle is required to restore the initialization state machine.

The Brown-Out Reset threshold ( $V_{\text{BTH}}$ ) gap occurs because the brown-out supervisor has a threshold as low as 2.85 V, which is less than the minimum operating voltage on VDD, and also because it can take several microseconds to respond. BOR gaps can be encountered after power up, during steady state operation power-on, if the VDD rail has glitches, and also during power-down.

After initial power-up, any processor operation with VDD below 3.0 V may result in unexpected code execution resulting in the effects described above. The processor must be halted or the  $\overline{\text{RST}}$  signal must be driven Low prior to VDD dropping below 3.0 V and stay in that state until VDD is above 3.0 V.

If VDD falls below 2.1 V, it must continue to fall until it reaches 1.5 V. VDD must stay below 1.5 V for at least 36  $\mu\text{s}$  to ensure that a POR is triggered correctly. Additionally, the VDD power-up time between 1.9 V and 3.0 V must be at most 6.0 ms. If VDD falls below 3.0 V but stays above 2.1 V, it is not necessary for the voltage to continue falling below 2.1 V. VDD can come back up to 3.0 V without any additional timing requirements.

1. The VDD power-up, steady state, and power-down waveform meets the timing requirements shown in Figure 1 on page 11.

2. The power-up transition of VDD between 1.9 V and 3.0 V must not have any points where it decreases in voltage (must be monotonic).
3. The power-down transition of VDD between 3.0 V and 1.5 V must not have any points where it increases in voltage (must be monotonic).
4. Once steady-state operation between 3.0 V and 3.6 V is achieved,  $\overline{\text{RST}}$  must go Low or the CPU execution must be halted prior to VDD falling below 3.0 V.
5. The **Brown-Out Reset Control (PBORCTL)** register must be set so that a brown-out event causes a reset.
