Stellaris[®] LM3S8C62 RevA2 Errata

This document contains known errata at the time of publication for the Stellaris LM3S8C62 microcontroller. The table below summarizes the errata and lists the affected revisions. See the data sheet for more details.

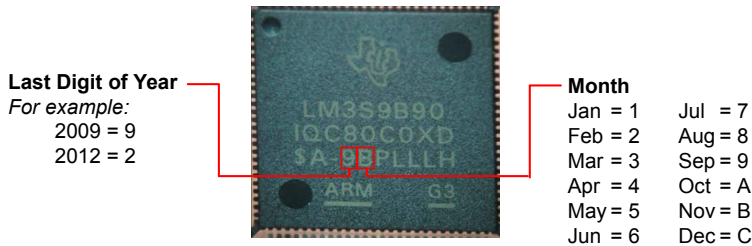
Note: To determine the date code of your part, look at the first two characters following the dash on the third line of the part markings (highlighted in red in the following figure). The first number after the dash indicates the last decimal digit of the year. The second character indicates the month. Therefore, the following example shows a date code of 9B which indicates November 2009.
