Stellaris® LM3S Tempest- and Firestorm-Class Microcontrollers Errata

Silicon Errata

Literature Number: SPMZ861

July 2014

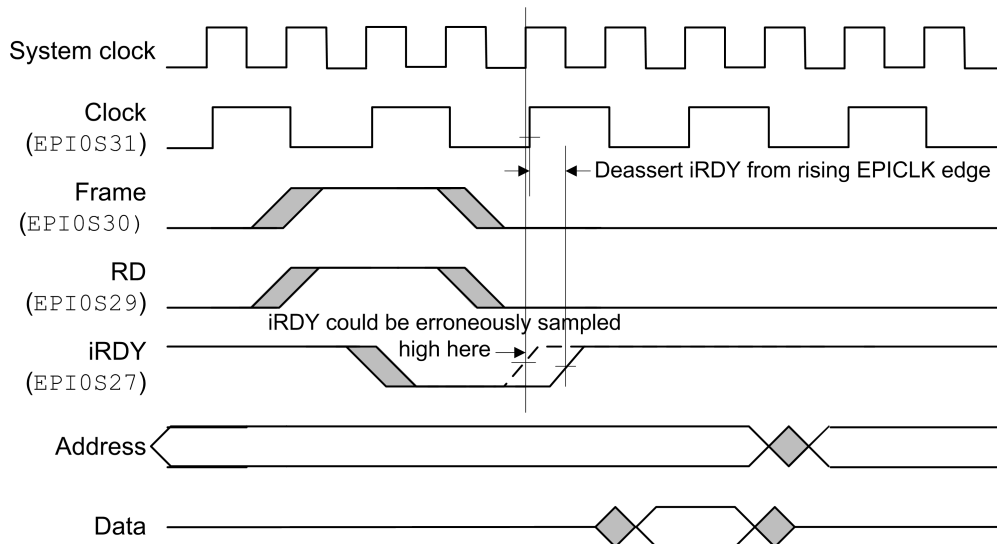
Figure 1. iRDY Timing

Description:	The data sheet specifies that ready input (iRDY) is sampled on the falling edge of the EPI clock, when it is actually sampled on the rising edge of system clock when configured for General-Purpose mode. The iRDY signal may be seen earlier than expected.
Workaround(s):	If trying to stall the address phase, this is not an issue. When trying to stall the data phase, you must ensure that iRDY is not deasserted until after the next rising edge of EPICLK. If iRDY misses the set up for the next rising system clock edge, it will be captured on the subsequent rising system clock edge. For example, if the system clock frequency is configured for 80 MHz (12.5 ns period) and the EPI clock frequency is configured for 40 MHz (25 ns period), there is a 2.5 ns window where the iRDY signal may be asserted ((25 ns – 12.5 ns) – 10 ns, where 10 ns is the iRDY assertion or deassertion set up time (TRDYSU)). Figure 1 shows where iRDY is actually sampled when trying to stall the data phase. iRDY should be deasserted after the next falling edge of EPICLK. iRDY could be erroneously sampled High if it is deasserted at the dotted line.

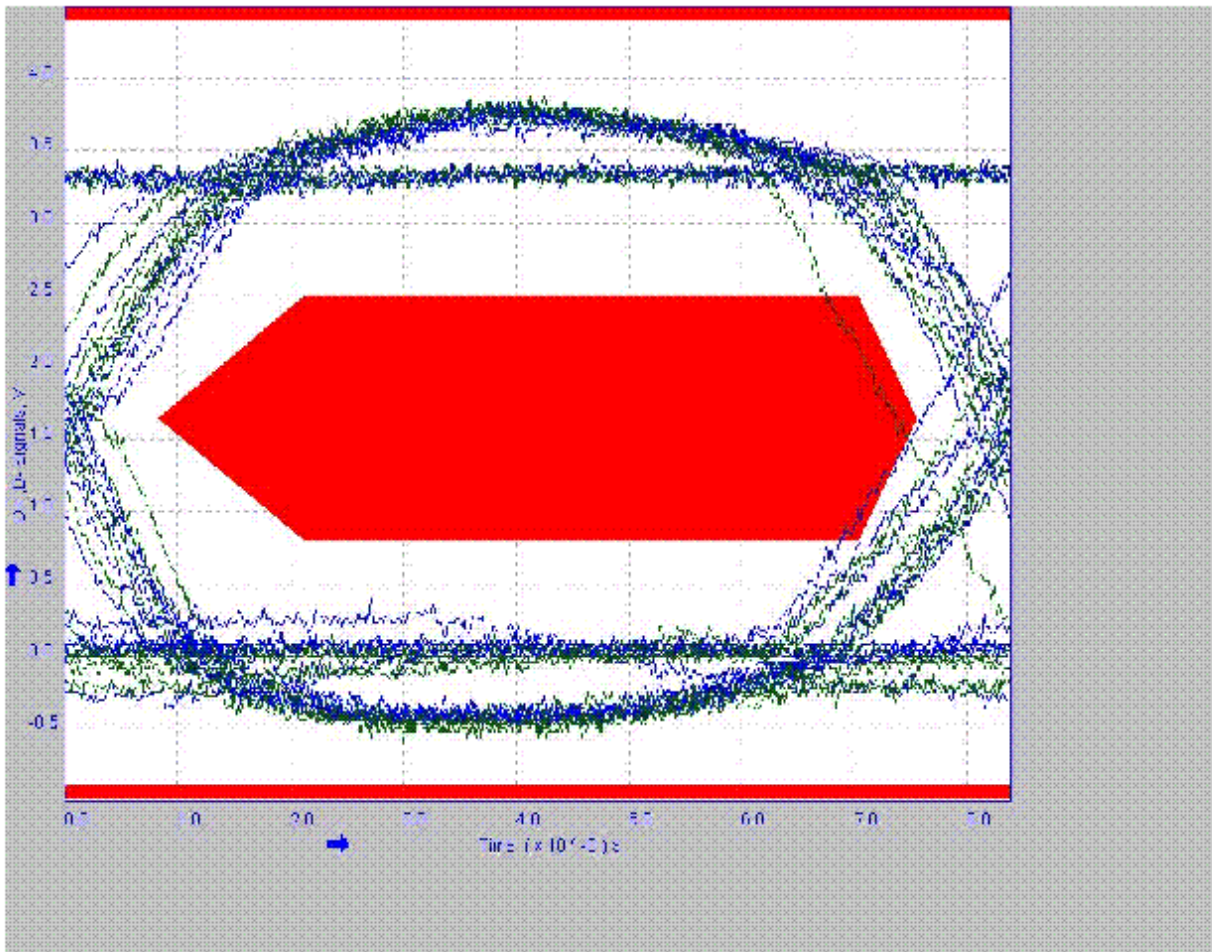
Figure 6. Example of USB Certification Failure

Description: If the EPI module is operating, the USB interface may fail USB certification. Failures have been seen for the eye diagram and jitter ([Figure 6](#)). Because of these issues, there is a potential for data corruption on the USB interface when using the USB and EPI at the same time. The risk of data corruption is small, but is dependent on the system design.

- Signal eye:
Eye Diagram Test fails

- EOP width: 169.0995ns
EOP width passes
- Receivers: reliable operation on tier Tier 6
Receivers pass
- Measured Signalling Rate: 11.92707Mbps
signal rate conditionally passes
- Crossover voltage range: 1.546667 V to 1.680000 V
Mean crossover = 1.615889 V
First crossover at 1.660000 V(11 other differential crossovers checked)
crossover voltages pass
- Consecutive jitter range: -165.1885ns to 1.811468ns, RMS jitter 52.27256ns
Paired JK jitter range: 752.3810ps to 2.871429ns, RMS jitter 1.821542ns
Paired KJ jitter range: 1.185714ns to 2.168571ns, RMS jitter 1.695397ns
jitter fails

Workaround(s): None.

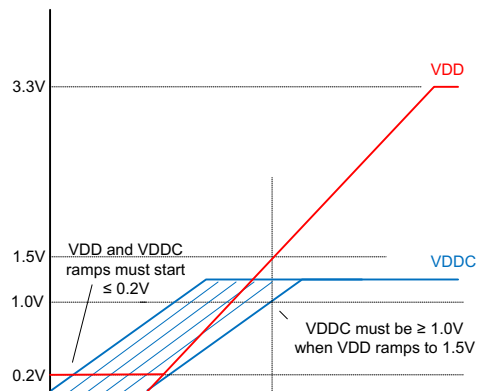
Figure 7. V_{DDC} and V_{DD} Rise Time Relationships

Description: There is a small risk of flash corruption or device failure on power up. The issue can occur with certain V_{DD} and V_{DDC} power sequences. The failure is not in the flash memory itself but in the control logic to the flash.

Figure 7 details these requirements. Three workaround circuits have been identified that meet these requirements and are described below.
